PHOTOGRAPHIC RECORD – Site Audit Visit, 26 May 2023, Conducted by Dr Vanessa Weyer

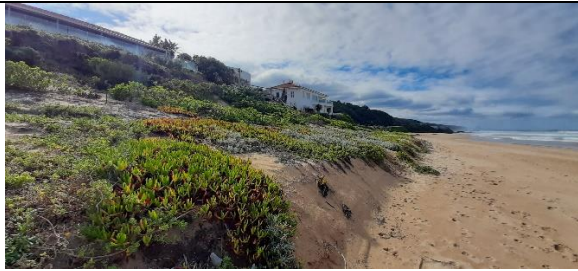
Image 1:
Rehabilitated dune vegetation showing good coverage, view to the north-east.

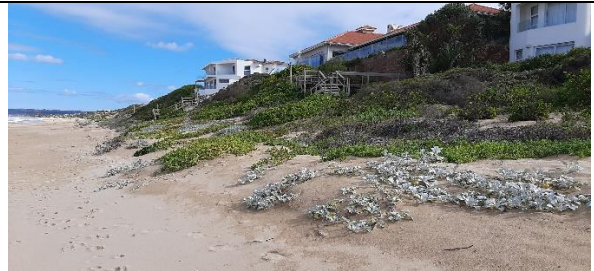
Image 2:
Rehabilitated dune vegetation showing good coverage, view to the south-west.

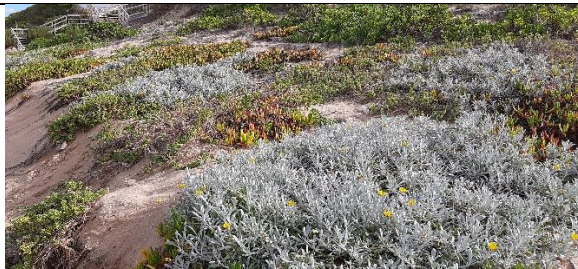
Image 3:
Close up view of successfully established dune plant species.

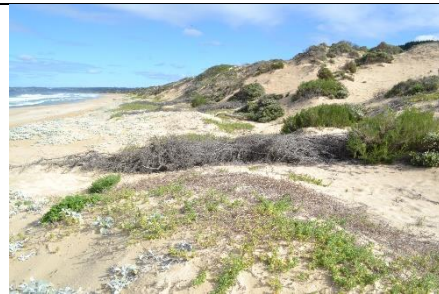
Image 4:
Cut brush used as natural fencing for wind and sand protection, to encourage dune rehabilitation, still in place and functional.

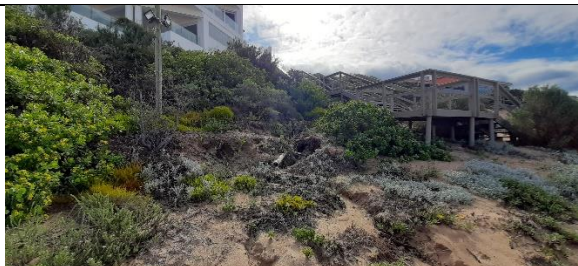
Image 5:
Stormwater outfalls between housing require attention, to mitigate against soil erosion - as part of the ongoing Maintenance Management Plan

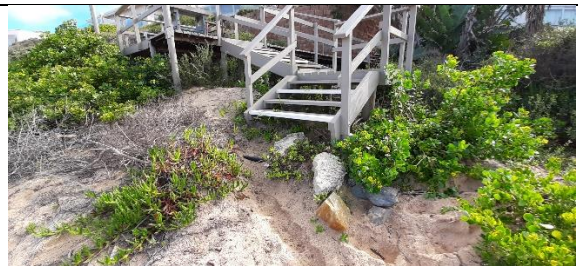
Image 6:
Footings under step entrances from houses require attention - as part of the ongoing Maintenance Management Plan

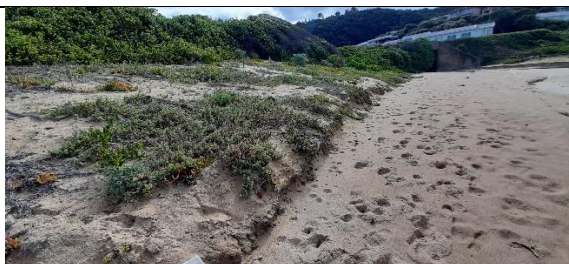
Image 7:
Some scour has occurred along the stream edge, east section of site. This is to be expected and will be ongoing, to be monitored and repaired as part of the Maintenance Management Plan.

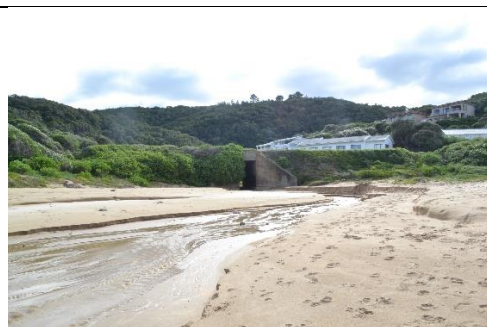
Image 8:
View of stream flow. Note ramp to the right of the stream has been rehabilitated.

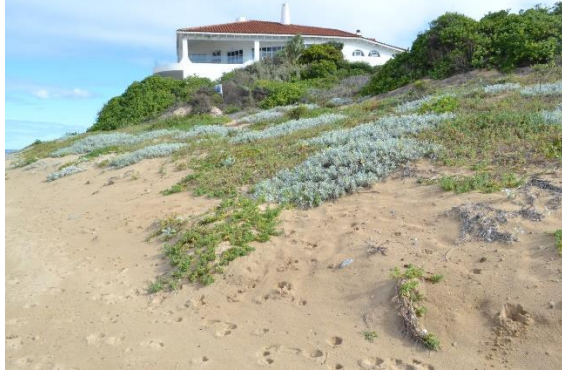
Image 9:
Construction vehicle access between houses has recovered well and is showing good rehabilitation results.

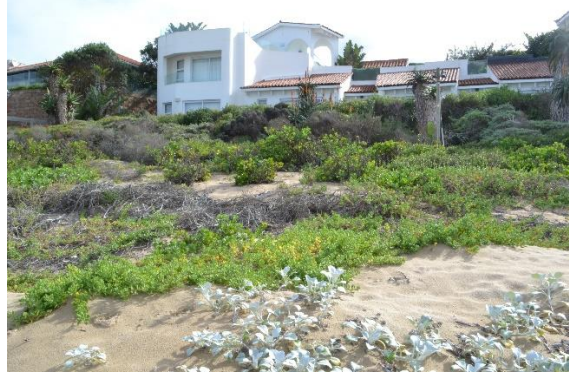
Image 10:
Well established plant material.

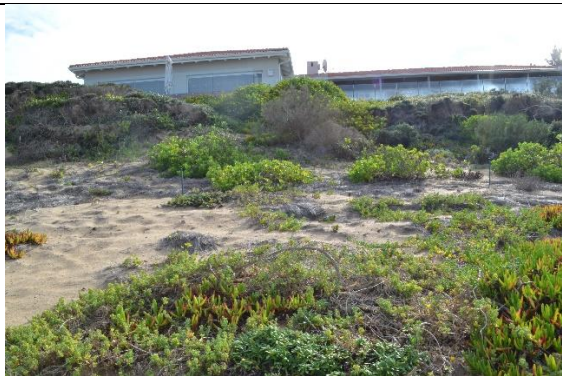
Image 11:
Dune vegetation establishment has been aided by water from irrigation sprinklers
