**Aquatic Specialist Inputs to The Proposed Bank Stabilisation of an  
Unnamed Stream on RE/12861 in Boland Park, Mossel Bay.**

**Prepared for HiLLand Environmental (Pty) Ltd & SMEC SA, George**

**Dr. Jackie Dabrowski**

**Confluent Environmental (Pty) Ltd**

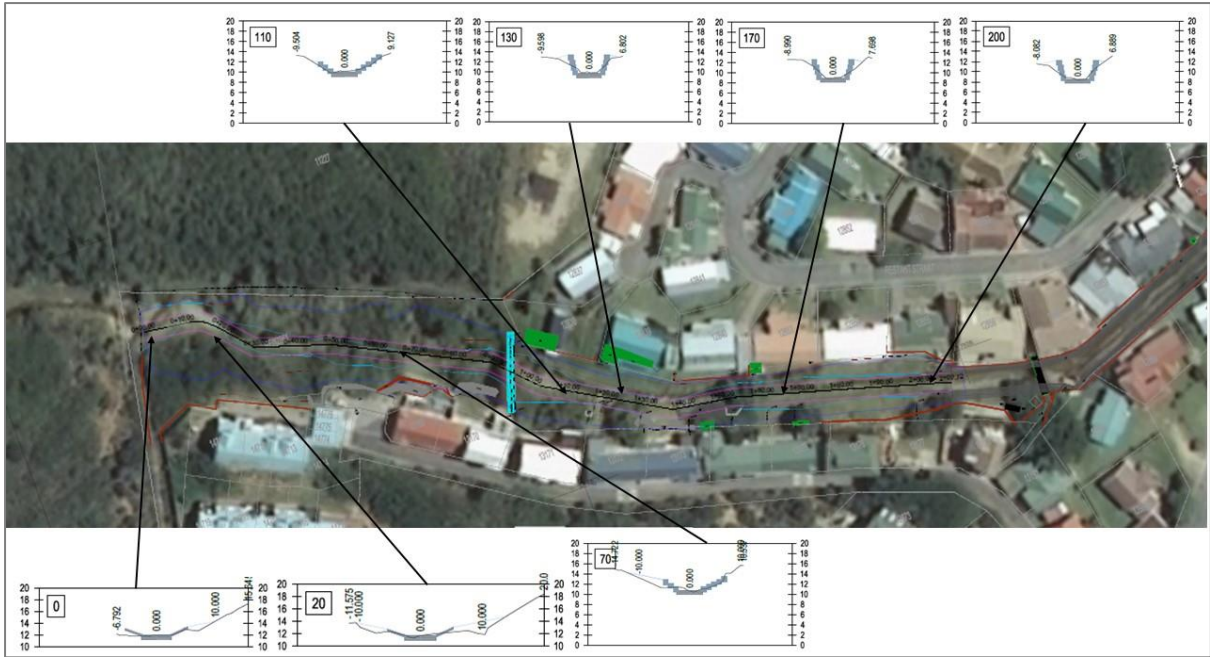
Figure 1. Simplified layout plan showing proposed cross-sectional bank and bed stabilisation (Modified from Appendix 1).

Further upstream, where the gabions end, houses constructed on steep slopes above the stream are showing signs of slippage down the slope. Several houses have visible cracks and unstable retaining walls. In the stream below, minor erosion is taking place, but in order to prevent collapse of the banks and houses above the banks, the Mossel Bay Municipality would like to extend the gabions further up the stream, and would also like to replace the stream bed with open pavers (See Appendix 1 for plan; Figure 1 and Figure 2).

In this situation where space is constrained and infrastructure is at risk if banks should collapse, a gabion retaining wall is justified. For instance, moderate erosion is taking place at the toe of the bank at around 110m cross section (Figure 1 and Figure 12). However, the risk

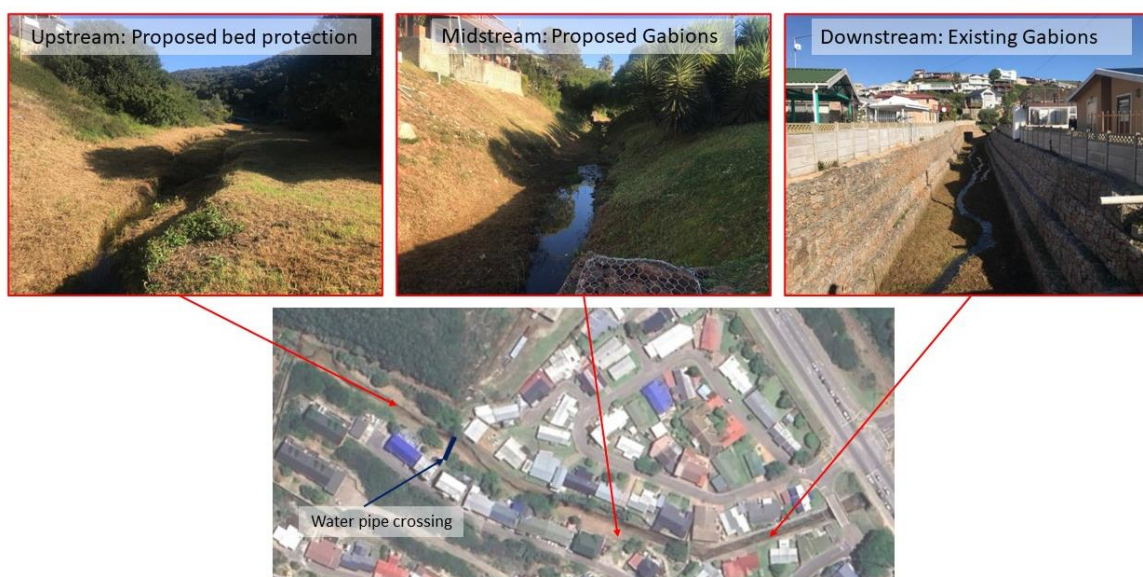
Figure 7. Photos of typical stream sections.

The site was visited on 27 May 2022 which is considered winter. Conditions on the day were clear and sunny, and no significant rainfall had been recently recorded in the area. The full extent of the proposed stream reach for bank protection was walked in both upstream and downstream directions. The inspection included the downstream section that is already modified with gabions and open pavers (Figure 7).

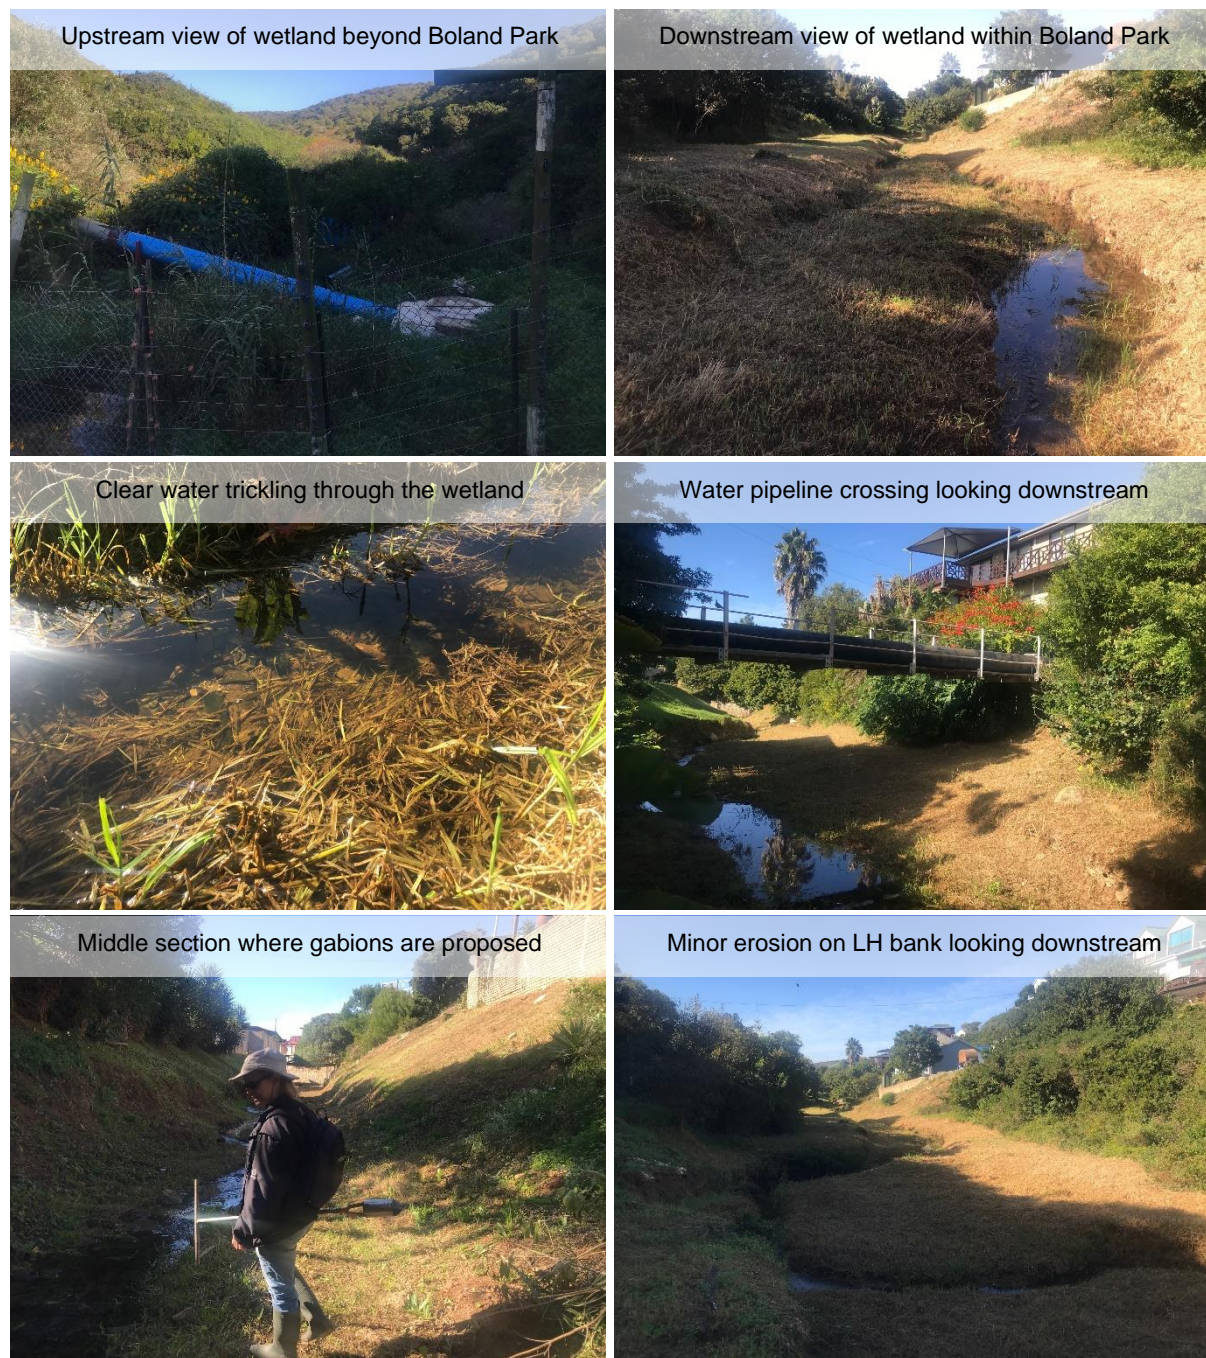
Figure 9. Photos of various aspects of the wetland considered in the PES assessment.

The Present Ecological State of the small wetland area upstream of the pipeline crossing was determined to be in a **C/D category** which indicates Moderate to Largely Modified conditions (Table 1). This was mainly due to the system’s hydrology which has been influenced by increased flood peaks due to development in the catchment. The wetland’s geomorphology is in largely natural condition, while the vegetation has been moderately impacted by frequent mowing (Figure 9). The fact that indigenous wetland species (e.g. *Cyperus textilis*) are still rooted at the site and will regrow is a positive aspect. If left to regenerate the vegetation should recover well, as it hasn’t been physically removed in this area.

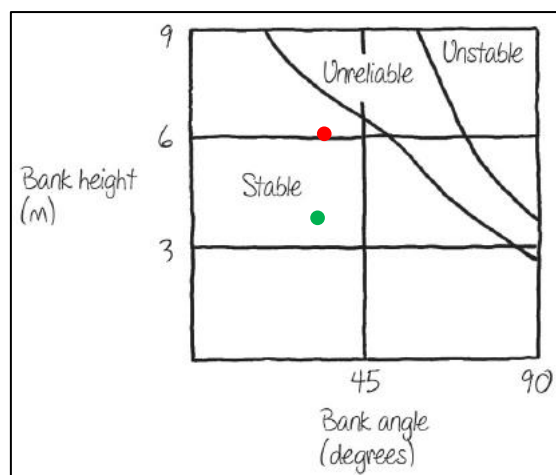
Figure 11. Dependence of bank stability on bank height and angle. Used as a general guide (Federal Interagency Stream Restoration Working Group, 2001). Red dot is approximate right-hand bank, and green dot is the left-hand bank.

Areas of the watercourse where banks have a steep gradient with houses constructed above represent a risk to infrastructure (Figure 11). The right-hand bank is approximately 6m high (rise) over a distance of 8.6m distance (run) which is a bank angle of 35° (70% slope). The left-hand bank is approximately 3.5m high over a distance of 5.9m which is a bank angle of 31° (60% slope). The general guide for bank stability given in Figure 11 indicates that although both banks have steep slopes, they are still within the stable category, but heading towards unreliability. Given the existing and ongoing development in the catchment, generating increased stormwater runoff, this risk will be increased in the future.

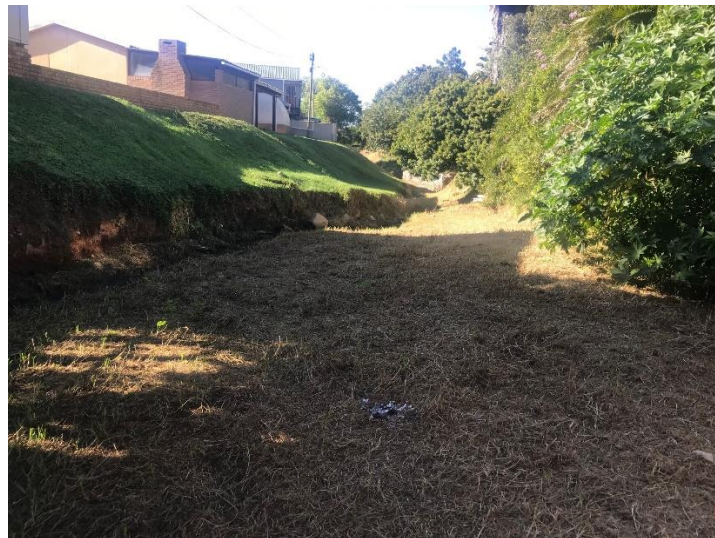
Figure 12. Most eroded bank on the left-hand side around the 110m cross section.
