# **PACALTSDORP RESERVOIR AND WATER TOWER, ON THE REMAINDER OF ERF 325, GEORGE LOCAL MUNICIPALITY, WESTERN CAPE**

**EXTERNAL ENVIRONMENTAL AUDIT REPORT IN TERMS OF  
REGULATION 34 OF THE NEMA EIA REGULATIONS, 2014 (AS AMENDED)**

**Development Phase: Civil construction completed.**

**EIA Reference Number: 16/3/3/1/D2/44/0019/23**

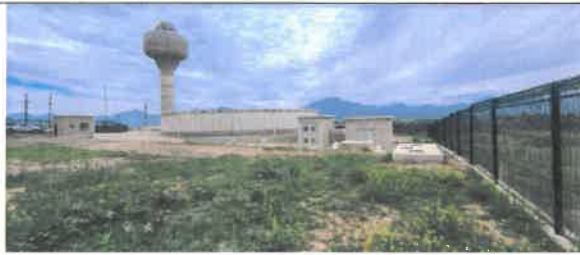
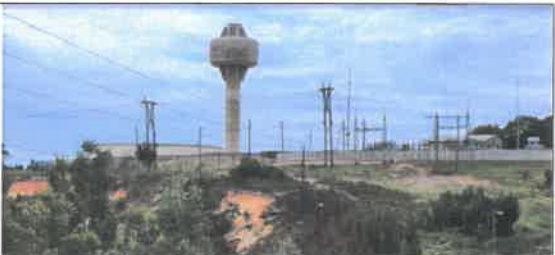
| <p>Civil construction infrastructure relating to the construction phase and containers were removed. Reservoir, water tower and associated infrastructure have been completed. The Clearvu site boundary fence is functional.</p> | <p>The eroded quarry was not negatively affected by the development.</p> |

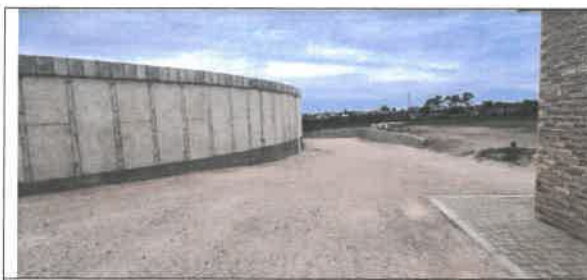
| <p>The parking area has been shaped and the contractors camp removed.</p> | <p>The clear vu fence is in place and rehabilitation is in progress.</p> |

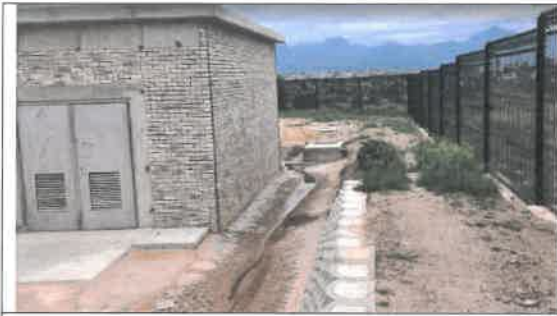
| <p>Stormwater management is satisfactory after a rain event.</p> | <p>Civil works have been completed and mechanical work to start in 2026 and to be completed in June 2026. The area at the blue pipe was left open for the mechanical works to take place.</p> |

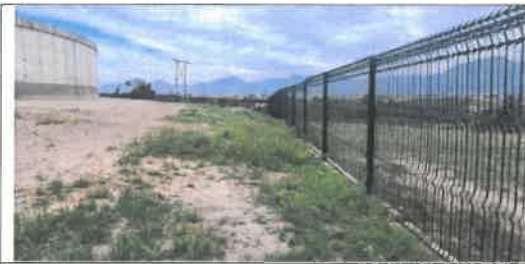
| <p>Rehabilitation in low lying and level areas is more successful than in steeper areas.</p> | <p>Rehabilitation in some steeper areas needs monitoring and additional seeding and watering if required.</p> |

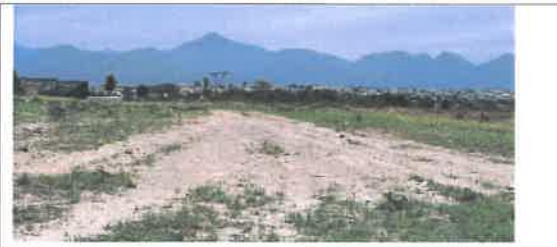
| <p>Regrowth is taking place in the pipeline footprint.</p> | <p>Rehabilitation of the pipeline footprint is not yet complete.</p> |
