# **Stockpile Areas and Geotechnical Assessments for the Proposed Extension of Rand Street, George, Western Cape.**

## **Aquatic Biodiversity Assessment**

**Prepared for HilLand Environmental and SMEC**

**May 2026, updated August 2026**

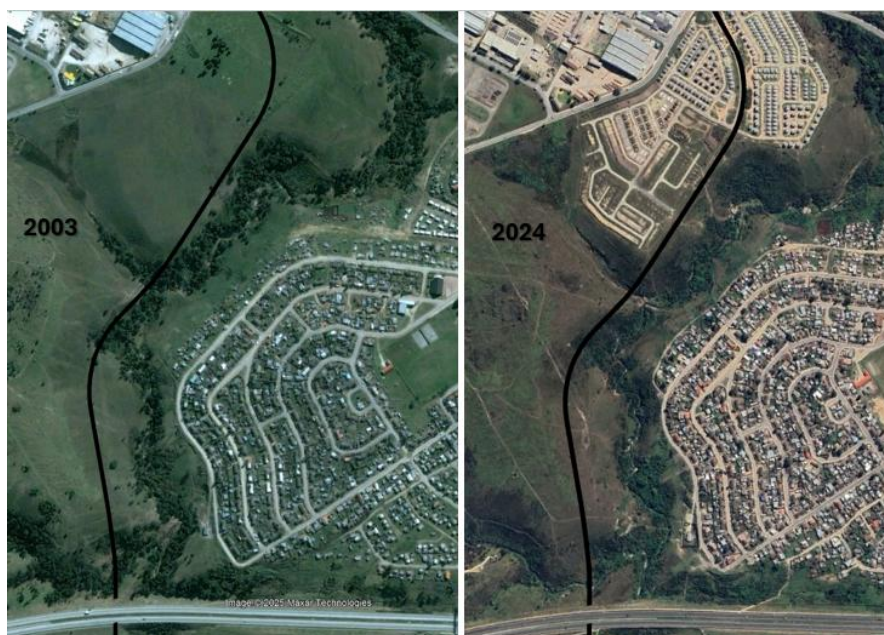
In the last two decades new areas of development in the catchment of the Skaapkop River and tributaries has occurred, and existing areas of development have expanded. The latter mostly due to informal housing extensions to formal low-cost housing areas. This pattern is evident in both the northern and southern sections of the proposed road extension and associated preliminary works (Figure 8 & Figure 9). In these images the extent of riparian vegetation appears fairly similar along the Skaapkop River, although it appears to be more dominated by bushy vegetation in 2003. The latter may have been alien vegetation that has been cleared. A distinct channel is evident along the watercourse in 2003 and 2024.

Figure 8: Comparison between the northern road section in 2003 and 2024 using satellite imagery.

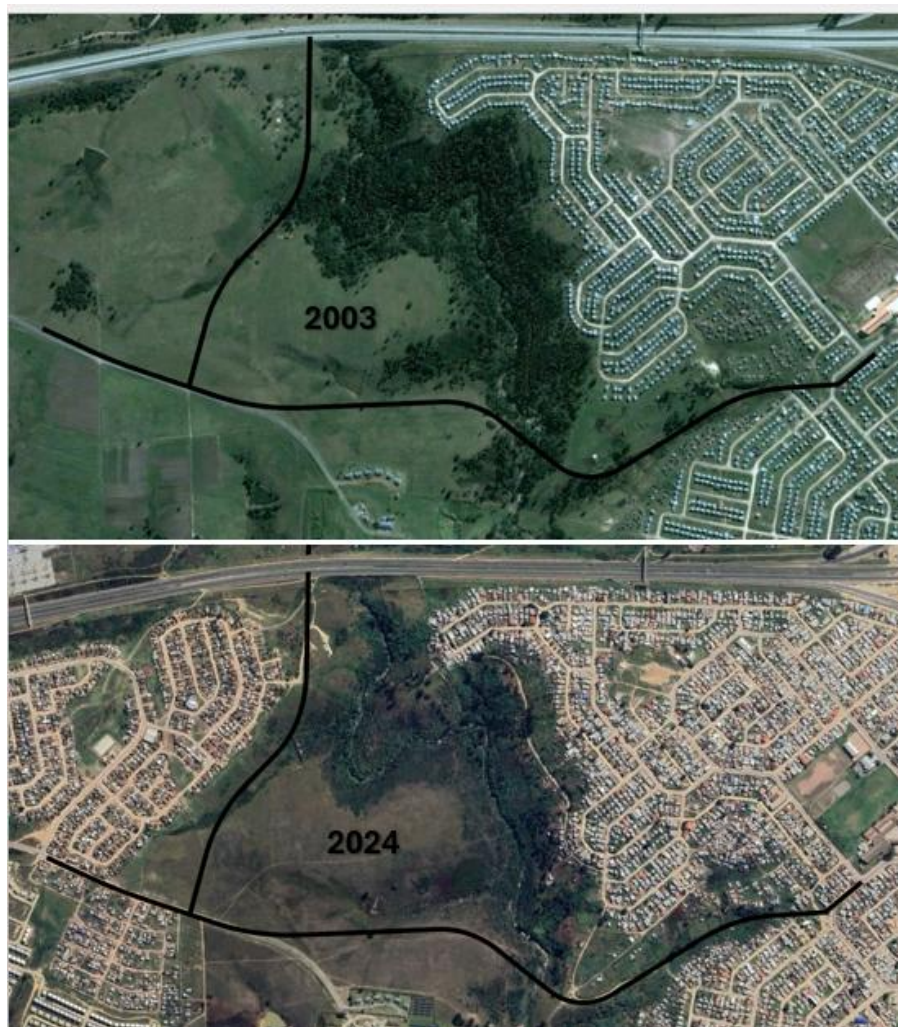
Figure 9: Comparison between the southern road section in 2003 and 2024 using satellite imagery.  
This is the area where all of the stockpile areas are proposed.

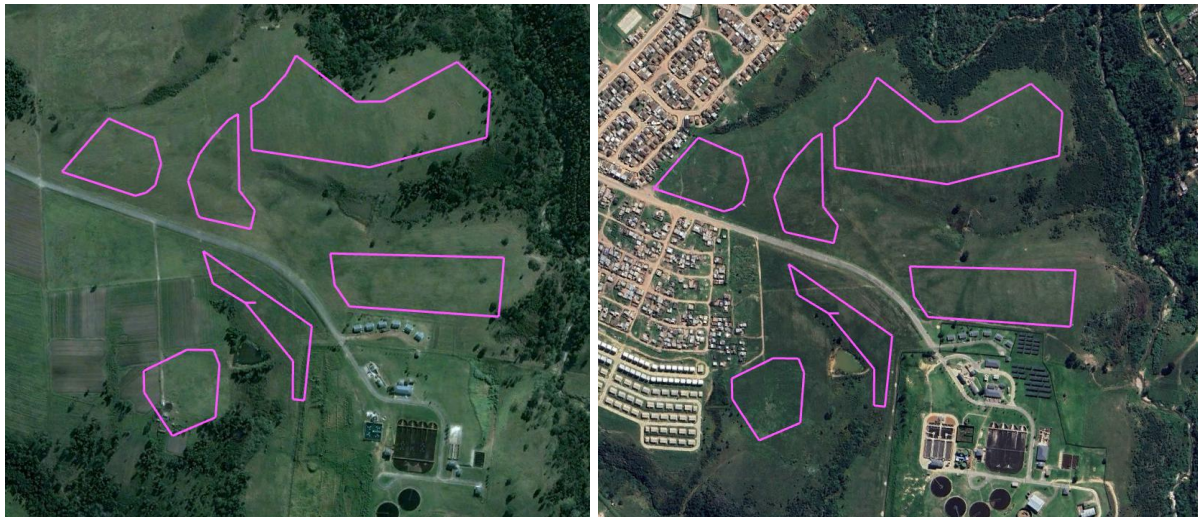
Figure 10. Stockpile areas compared between 1957 (top), 2003 (left) and 2025 (right).

The stockpile areas appear to have been burned or cleared in a linear fashion during 1957, and grazing was a likely land use. Now predominantly grassy fields, there is increasing development around them, and the original extent of wetland vegetation has receded, while woody alien vegetation has become dominant (Figure 10).

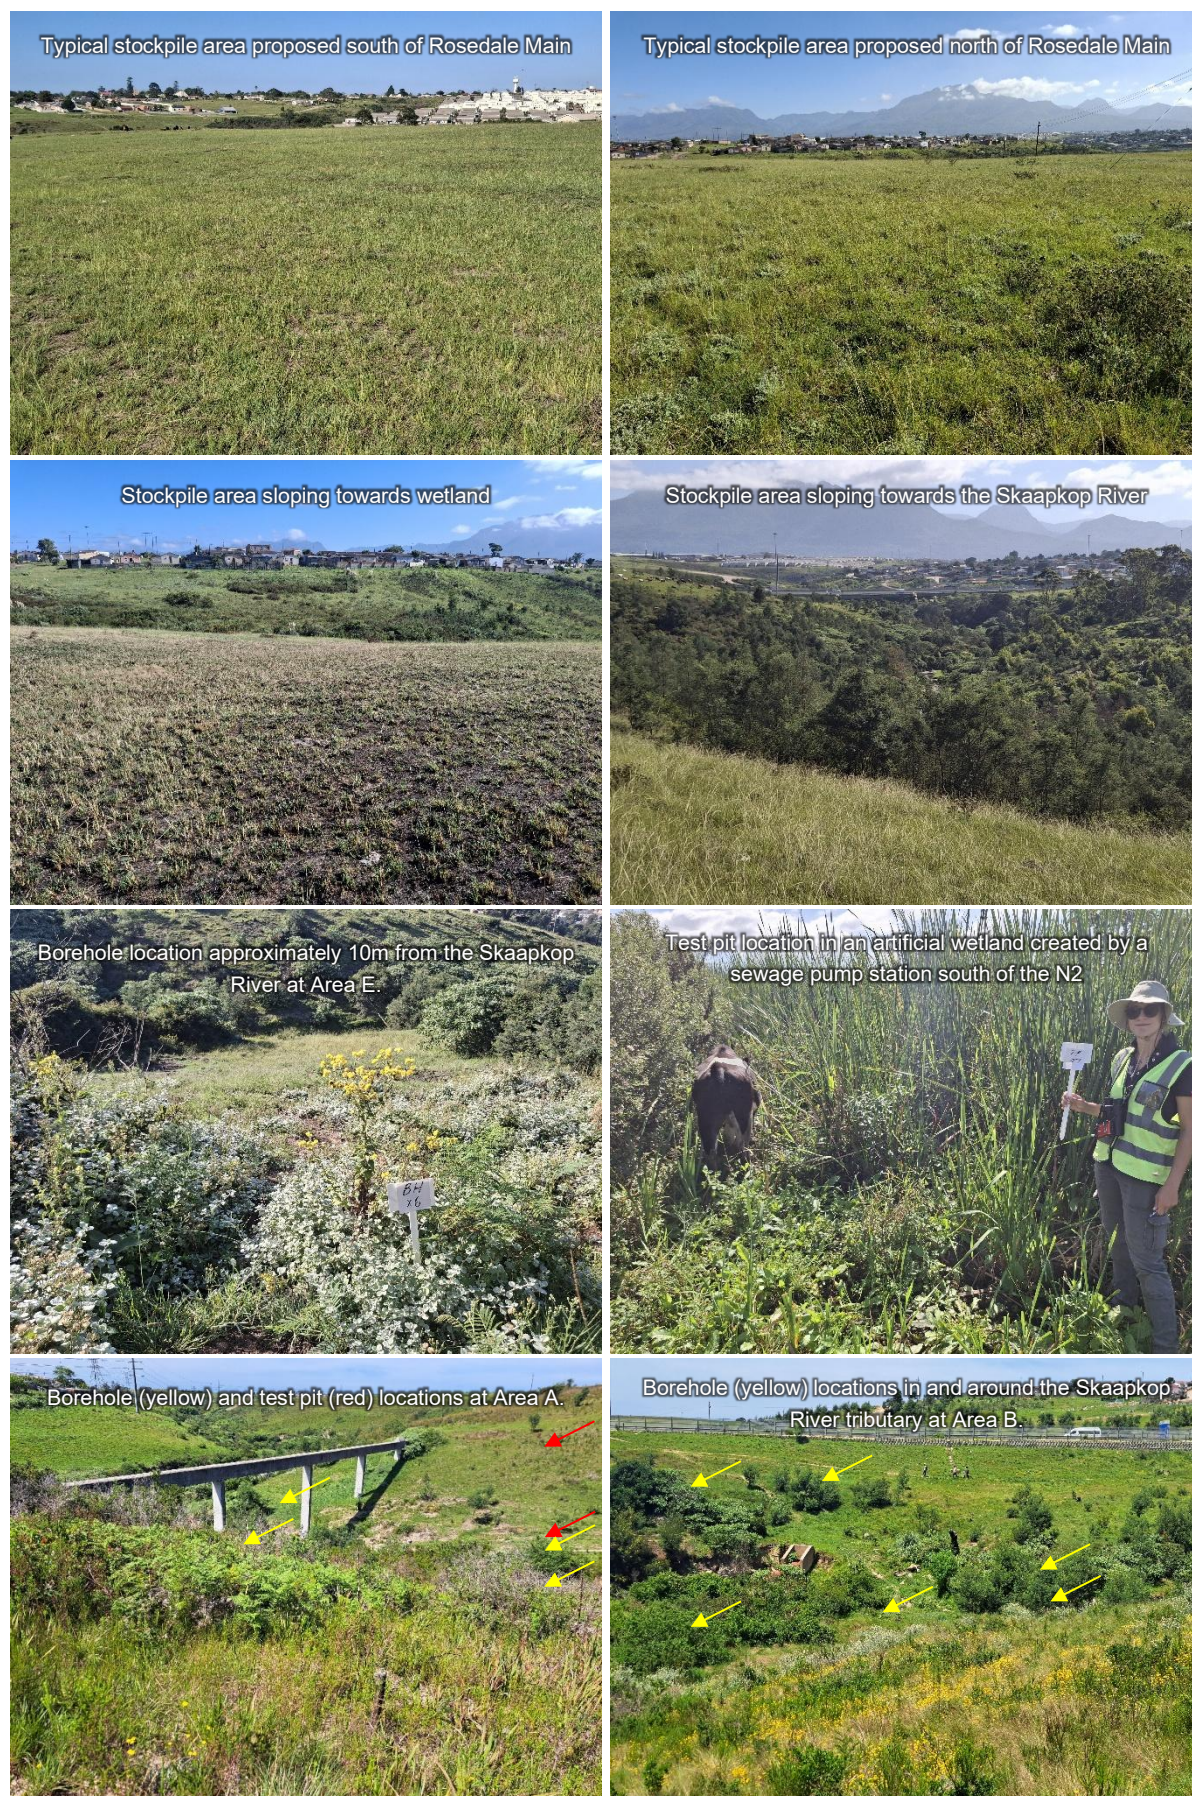
Figure 14. Photos of stockpile, borehole and test pit areas.

Of the 38 boreholes and 27 test pits, several are in, or very close to delineated wetlands / watercourses. These have been indicated as 'Areas' in Figure 13. The proposed stockpile areas are predominantly located on gently to steeply sloping land. The latter all eventually descend to valley-bottom wetlands on the slopes below. Photos taken during site visits are presented in Figure 14 with additional photos from more terrestrial areas provided in Appendix 2. Vehicle access to most areas would be straightforward on ground that is generally grassy and level. But some of the watercourses access points cover steeper ground with densely vegetated slopes.

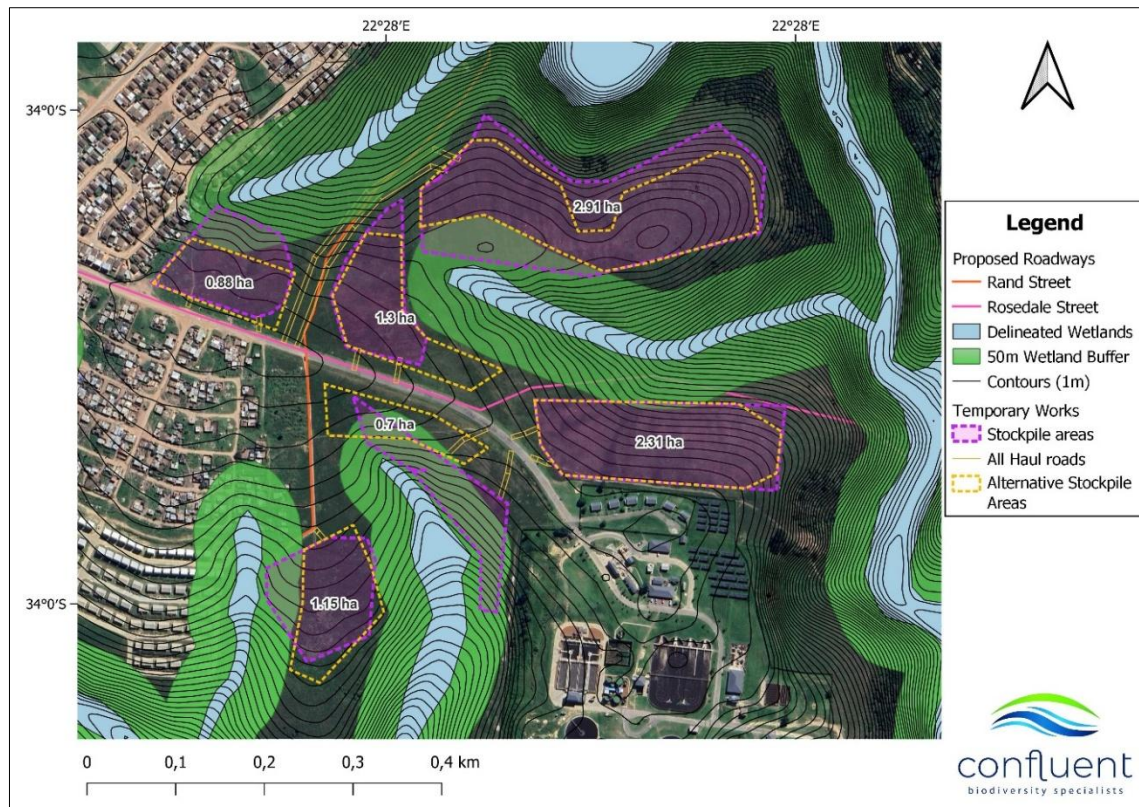
Figure 16. Proposed alternative stockpiling areas in relation to 50m wetland buffers and 1m contours.

- The primary mitigation measure is to reduce the stockpiling areas to align with areas of lower gradient situated at least 50m from delineated wetland areas (Figure 16 & Figure 17).
- It is recommended that all haul roads be realigned to enter the adjusted stockpiling areas (Figure 16) outside of the 50m wetland buffers. The haul road to the 2.91 ha field could be moved out of the buffer, or could connect via the 1.3 ha area, which could also be joined to the 2.91 ha area.
- If any area could be further reduced or removed, the 0.7 ha stockpile area would be recommended for removal given the practical difficulty of aligning it out of the buffer.

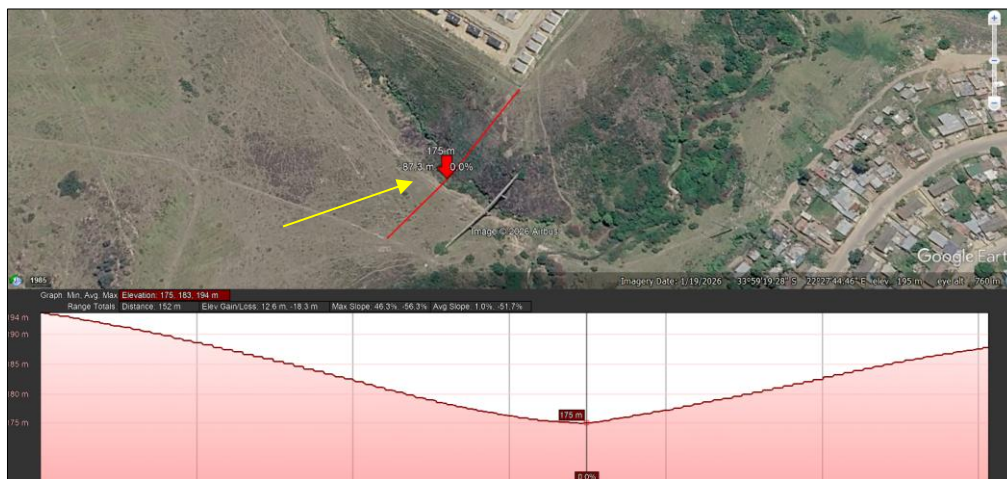
Figure 19. Google satellite image of Area A indicating the elevation profile (red line) across the valley with more dense vegetation and a steeper slope on the north-eastern side. Access here should be from the south-western slope (yellow arrow).

- Disturbance of vegetation can be mitigated by selecting the less vegetated and/or less steep of two slopes above a watercourse. E.g. at Area A, the western slope is less steep with much less dense and sensitive vegetation than the eastern slope. It is therefore recommended that access be obtained from the south-western slopes as far as possible (Figure 19 & Figure 20).

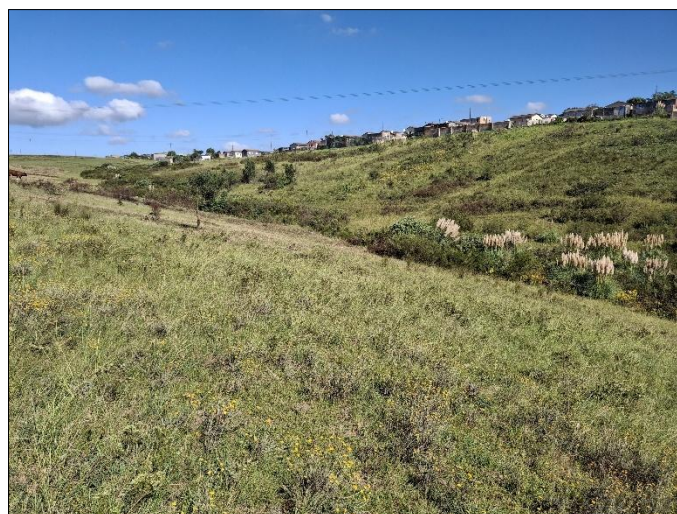
Figure 20. Example where the southern bank is less vegetated than the northern bank at Area C. In this instance, access should be prioritised from the southern bank.

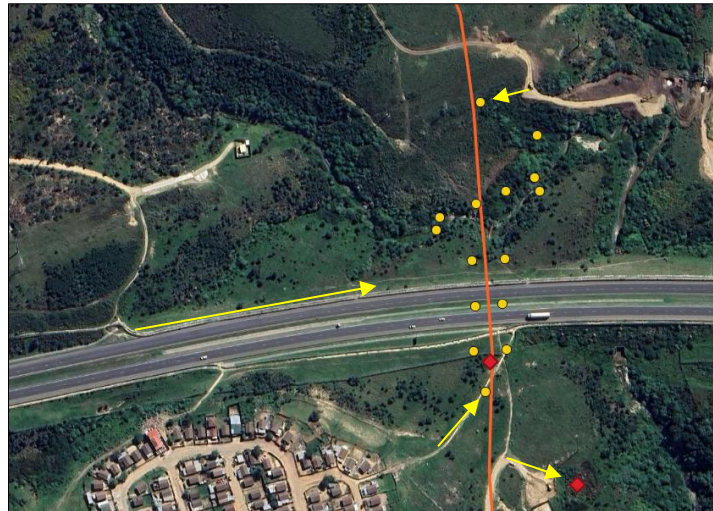
Figure 21. Area B indicating existing tracks (yellow arrows) from which access can be obtained to geotechnical investigation points.

- Disturbance can be further limited by selecting access points using existing tracks and pathways (Figure 21 & Figure 22). The access route selected should always prioritise existing disturbance areas over undisturbed natural vegetation, even if this means travelling over a longer distance.

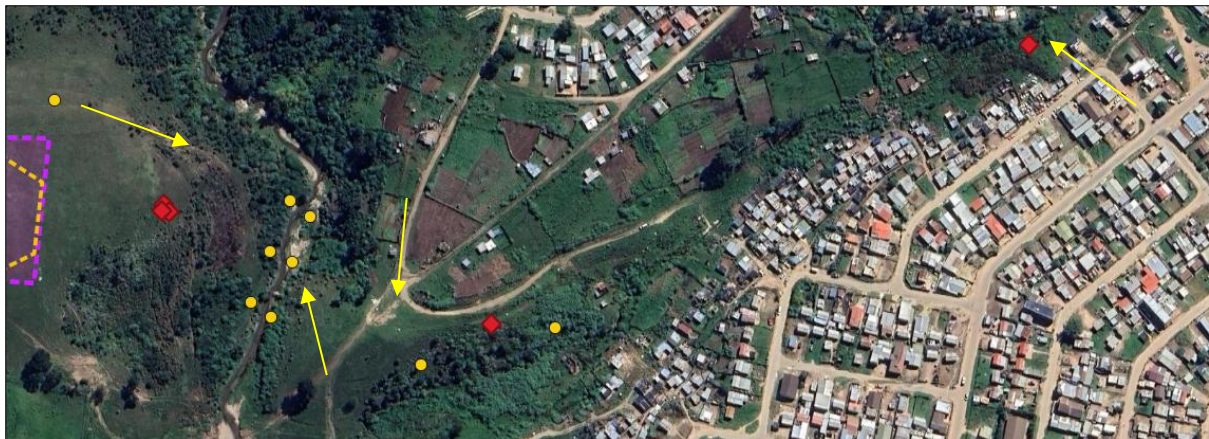
Figure 22. Area D and Area E showing existing tracks (yellow arrows) and roads that can be used to access geotechnical investigation points.

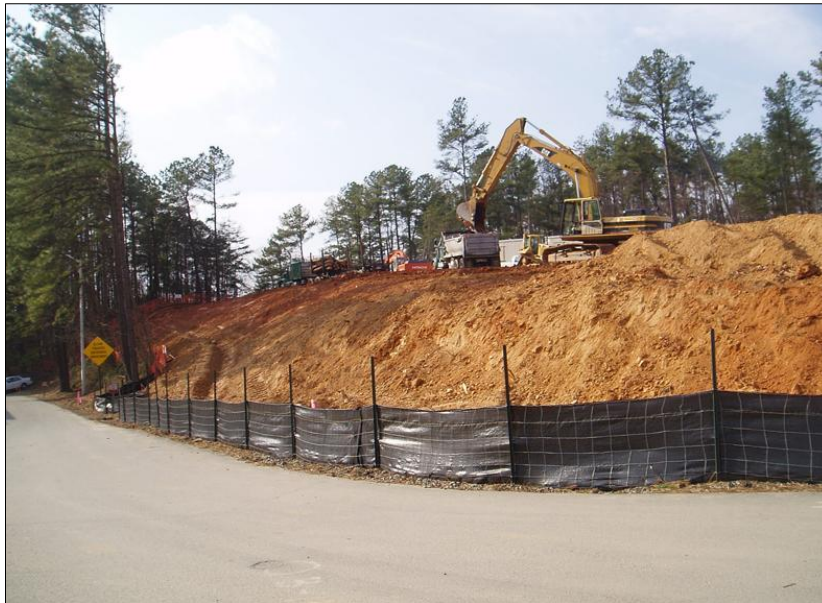
Figure 23. Example of silt fence attached to perimeter fence of a construction area.

- Survey and peg out each of the stockpile areas.
- Install a perimeter fence around the surveyed perimeter of the stockpile area. This fence can be basic (e.g. wire game fence) but may be upgraded depending on the security requirements of the site.
- When installing the above fence, dig in a layer of 70% shade cloth attached to the perimeter fence (e.g. with wire or cable ties) to double up as a silt fence on areas where runoff will exit the site (Figure 23). If it cannot be attached to the perimeter fence for some reason, then it should be dug into place approximately 50cm on the inside of the fenceline with dropper supports. This shade net may be attached along the full length and height of the fence to minimise dust, and provide screening for nearby residents.

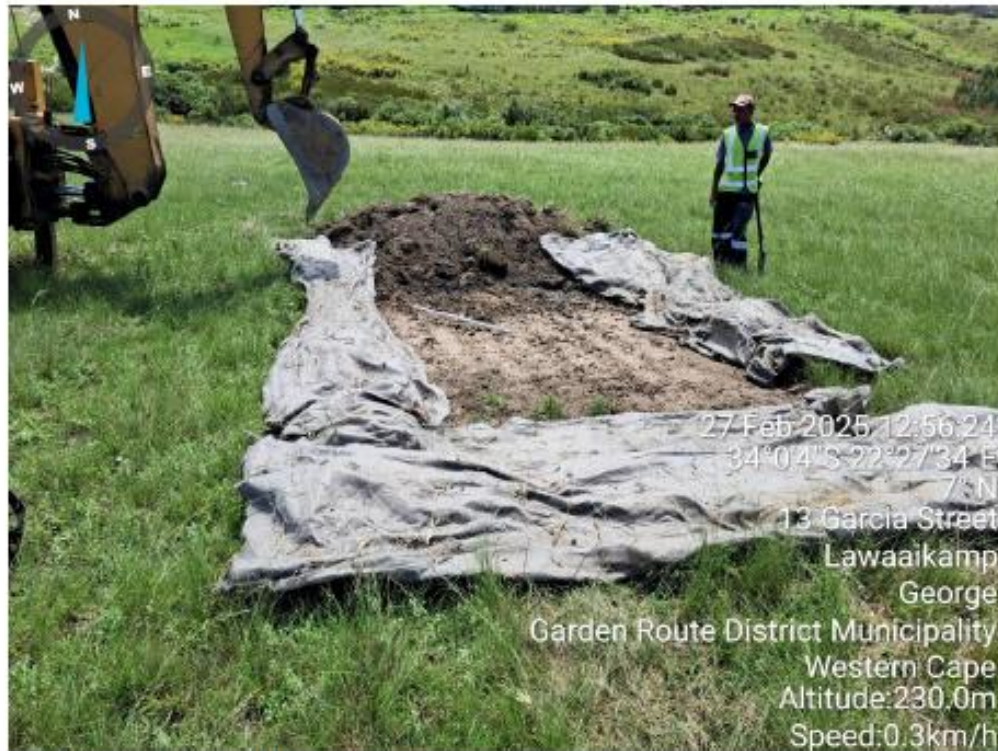
Figure 1 Example of stockpiling topsoil

- Excavated soils to be placed on heaps not more than 1.5 meters high.
- Soil heaps to be placed in easily reachable position from the excavation on geofabric to prevent further damage of vegetation. Topsoil shall be placed separately. During backfilling, the topsoil will be reinstated last.

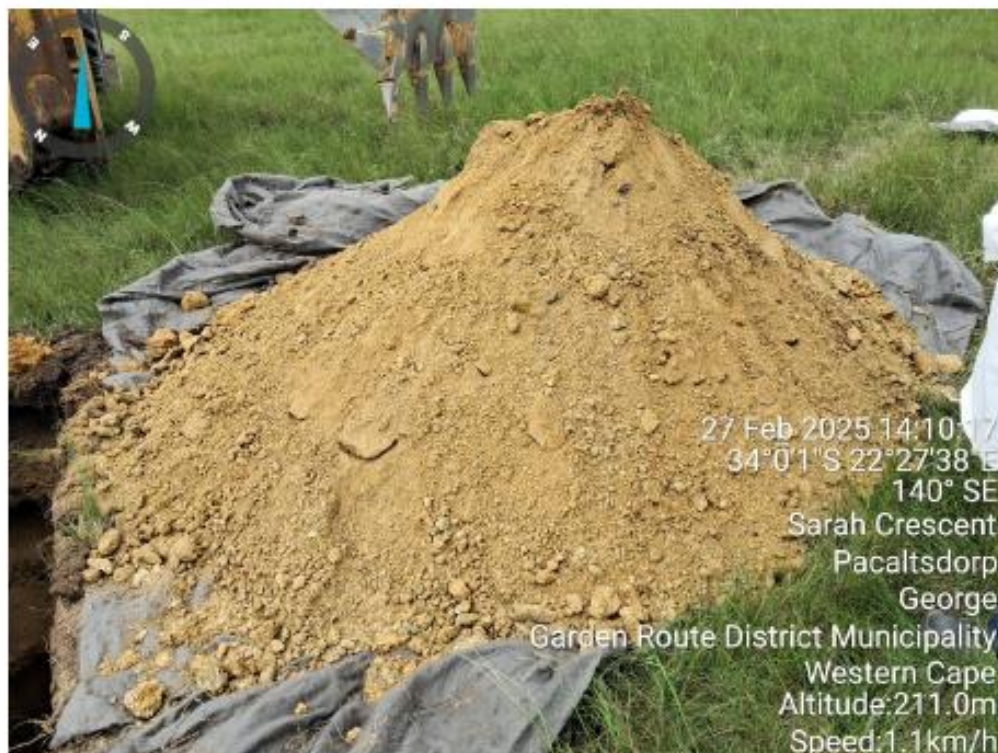
Figure 2 Example of stockpiling in-situ material

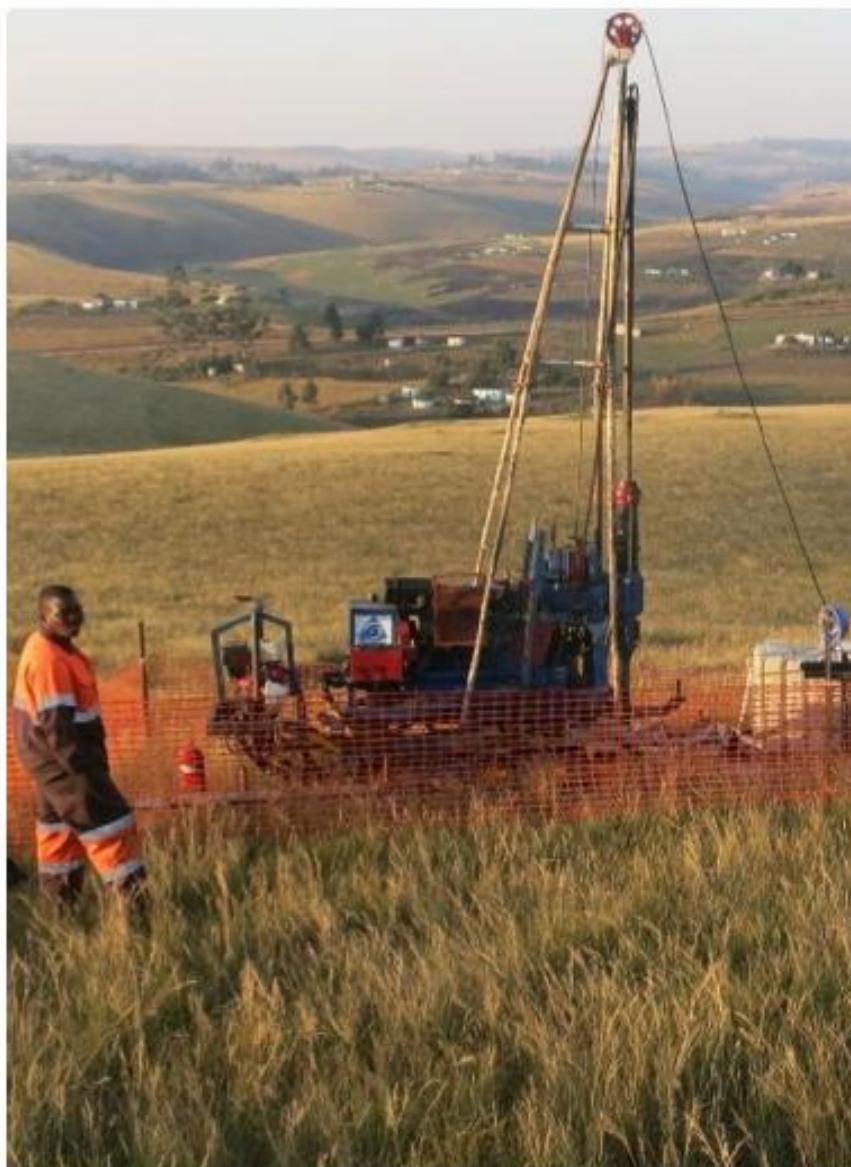
Figure 4 Example of core drill set up

- f) Commence by opening guard and attaching core barrel, close guard, start pump and commence drilling. Once the run has been completed, pull back with hydraulics until core barrel coupling is visible, loosen head with pipe wrench, lift hydraulic head up to the top, open guard and remove core barrel by hand.

- n) Backfill sumps, level ground surface, place the topsoil, and remove all waste from site.
- o) Typical core drill setup is shown in the figures below.

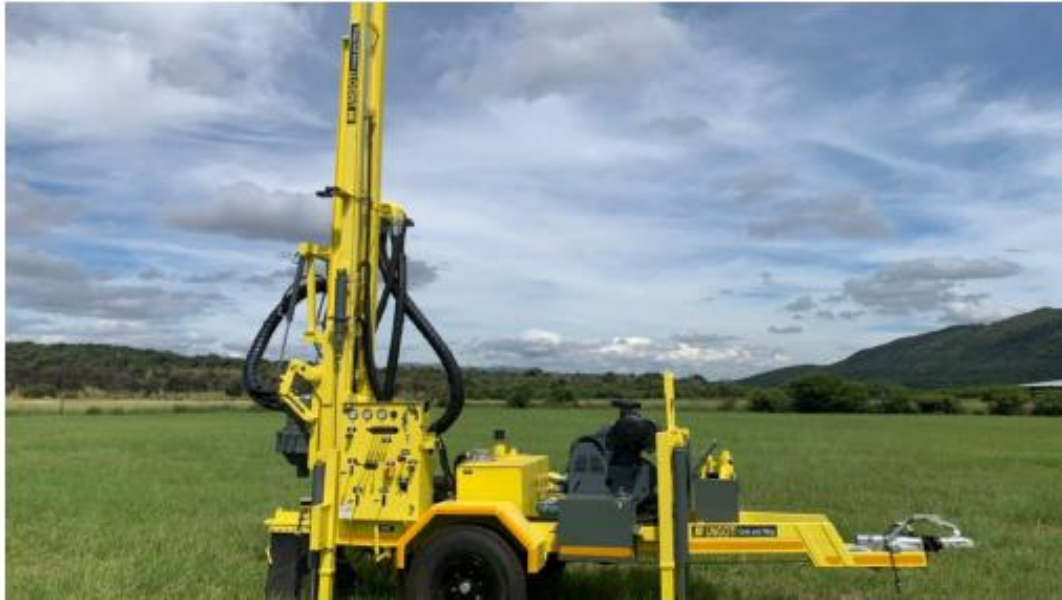
Figure 5 Example of trailer mounted rigging
