## Specialist Archaeology Assessment Hoogekraal Farm Estate near Glentana, George

For: HilLand Environmental

Date: August 2026

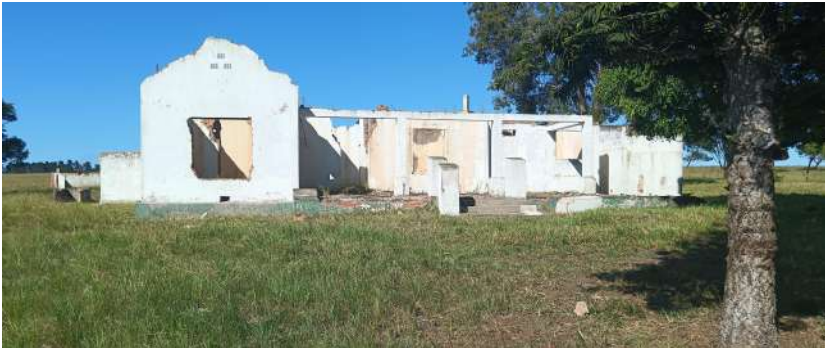
| 7 | Ruin of historic farm house.<br>Same as ID#1 in Aikman (2005) | NCW | |

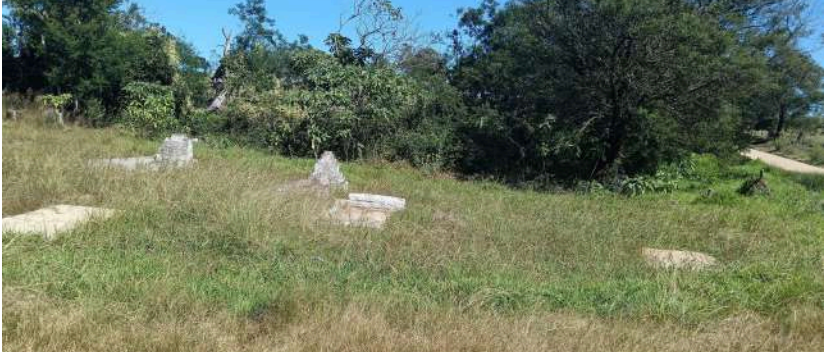
| 8 | Burial ground at road intersection. Consists of a number of clearly visible modern burials. Same as #11 below | IIIA | |

It is further recommended that the current informal cemetery be formalised through the erection of a fence, with access to the cemetery guaranteed throughout the life of the development. Any proposed roadworks located within 10m of the existing cemetery must be monitored by an archaeologist to ensure that no unmarked burials are accidentally impacted by any proposed development activities.

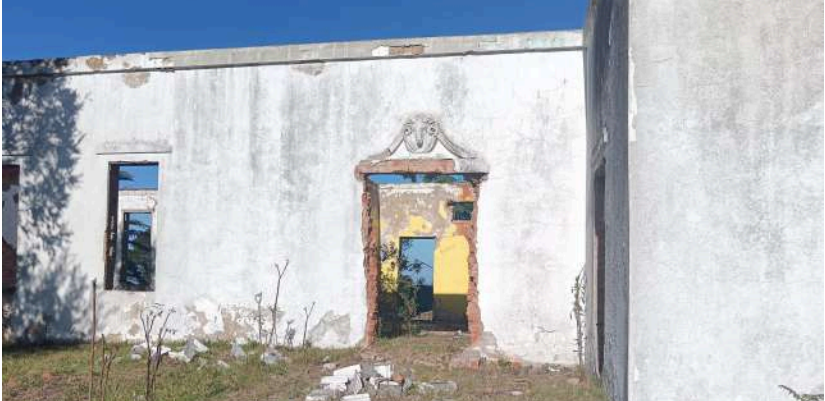
| 24 | <p>Ruins of Hoogekraal Historic Manor. In dire state of disrepair, extensively vandalised with no roof or windows. Said to be the oldest farmstead in the region dating back to the 1700s, the property has been systematically stripped. Some interesting features remain intact including ramshead and floral plaster detail above some of the doors, historic stone work visible in wall section. High likelihood of buried archaeology within the Hoogekraal werf precinct.</p> <p>The old manor house is said to have provided hospitality to early travellers as far back as the 1840s. Then, in the 1990s, it was used as a guesthouse run by Tony Botha, a former international banker and later an ANC politician, and his partner Colin Bryan. Botha is buried in the family graveyard.</p> <p>Same as ID#9 in Aikman (2005)</p> | IIIB | |

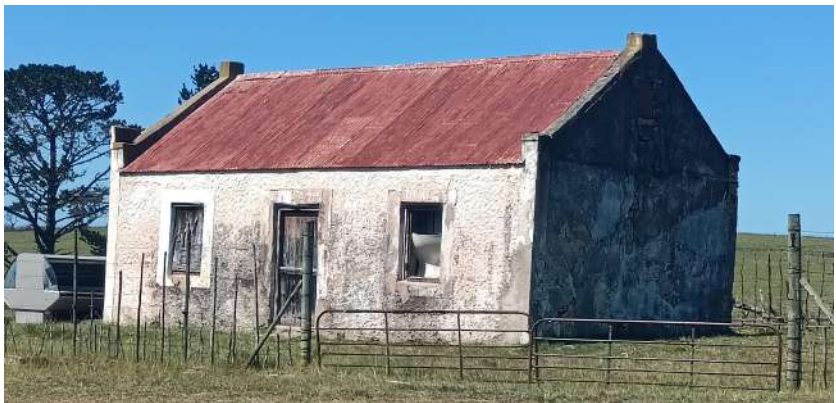
| 28 | Small historic cottage.<br>Same as ID#5 in Aikman (2005) | IIIC | |

Sites 17, 28, 35 and 52 are all small cottages located within the project footprint. Site 28 was graded IIIA by Aikman in 2005 and is described as "This small house probably dates from the mid to late 19th Century and is almost entirely intact. Its steep roof suggests that it may have been thatched originally. Its joinery is original. It is currently used as a store." In this report, it is recommended that this site be graded IIIC for its contribution to the agricultural context of the development area.

It is recommended that the above graded buildings are retained within the development and are not demolished due to their contribution to the broader agricultural context of the project area.

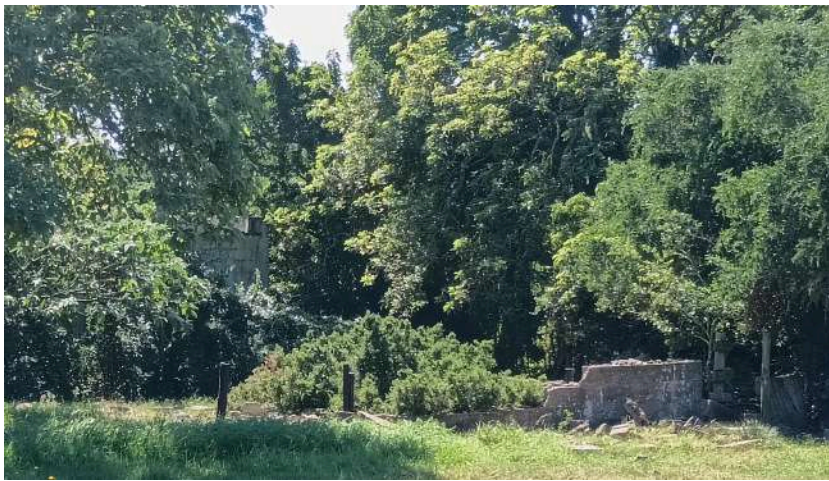
| 54 | Small ruin of structure within the Hoogekraal werf precinct. Potential archaeological value. | IIIC | |

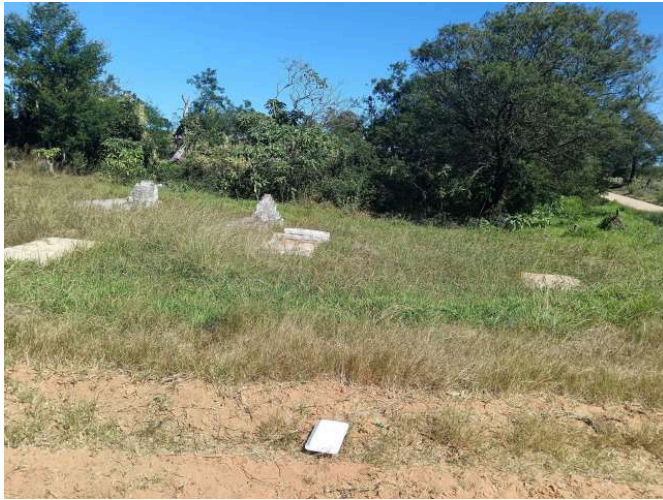
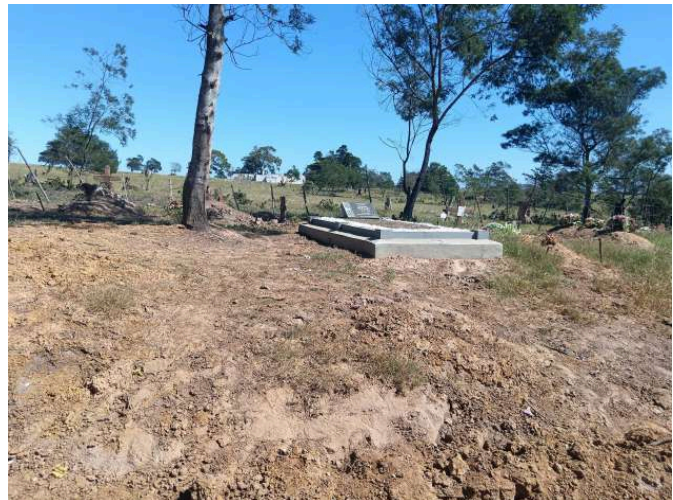
Figure 6.1: Site 8 and 11 - Road site burial ground

High cultural value is placed on human remains and as such, no impact to these sites can take place. There is a high risk of accidental impact or disturbance to these sites during the construction phase of development. Recommendations pertaining to the management of impact to these sites are included below. Furthermore, unknown or unmarked burial grounds and graves remain at risk during the construction phase and are likely to be subject to very high direct impacts without mitigation.

- The current informal cemetery (Site 8 and 11) be formalised through the erection of a fence, with access to the cemetery guaranteed throughout the life of the project.

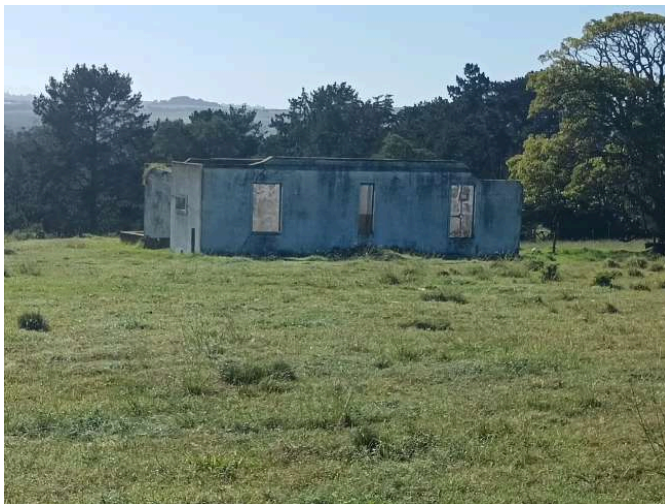
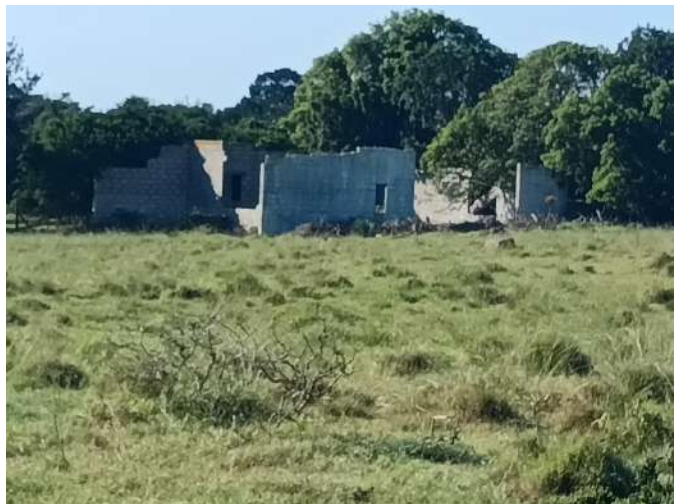
Figure 6.3: Site 23

| 23 | Ruins of the Smitswinkel and "Old School". Was likely one of the oldest structures in the broader area. Potential archaeological value. | IIIC | |
