Appendix C- Photographic Record of Silverstreams Estate, Erf 508, Proposed River Bank Maintenance

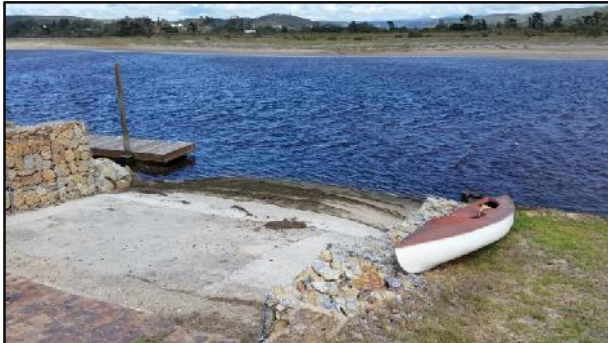
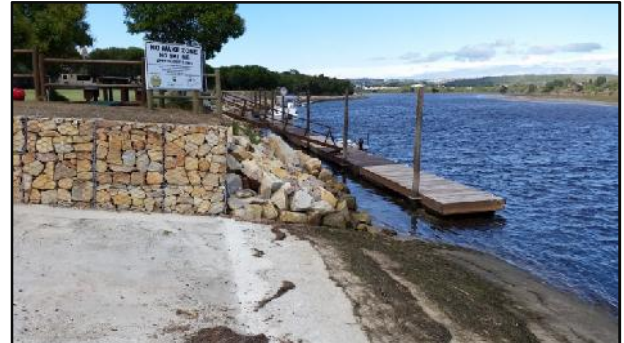
Existing slipway and recently upgraded retaining structure and floating jetty on Blue Waters Estate (adjacent property).

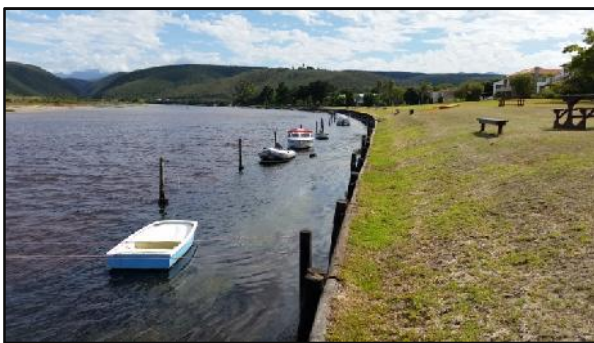
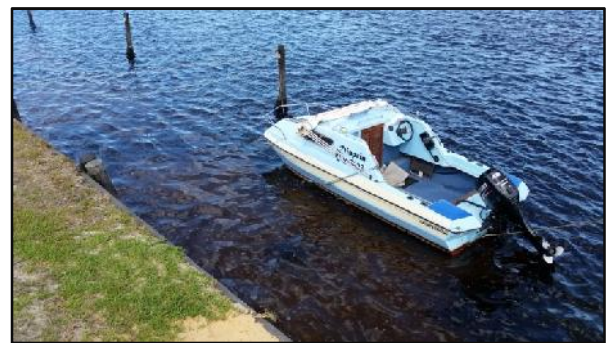
Creosote timber retaining wall and mooring poles that currently exist on Silverstreams Estate. This is not ideal as it results in owners trampling the intertidal zone at low tide to reach their boats.

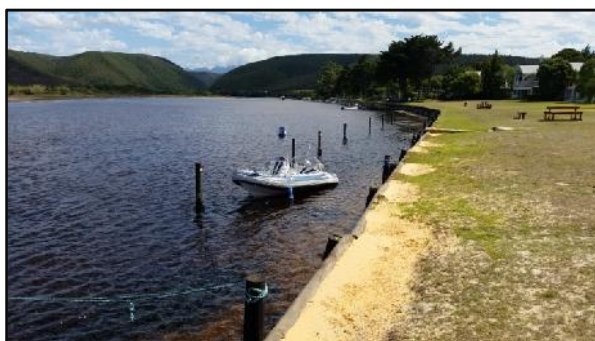
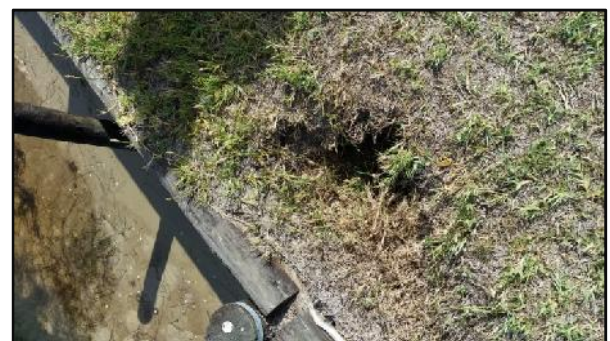
As can be seen on the above pictures, there is no remaining indigenous riparian vegetation on the banks of the river at this site. The area is covered by kikuyu lawns.

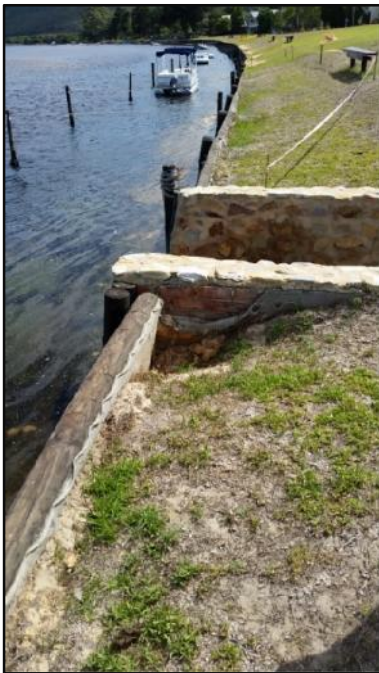
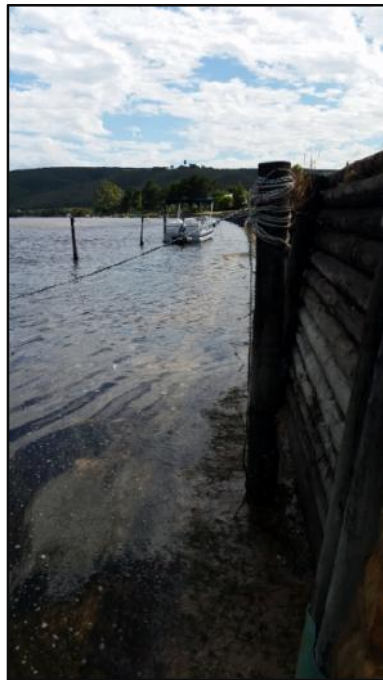
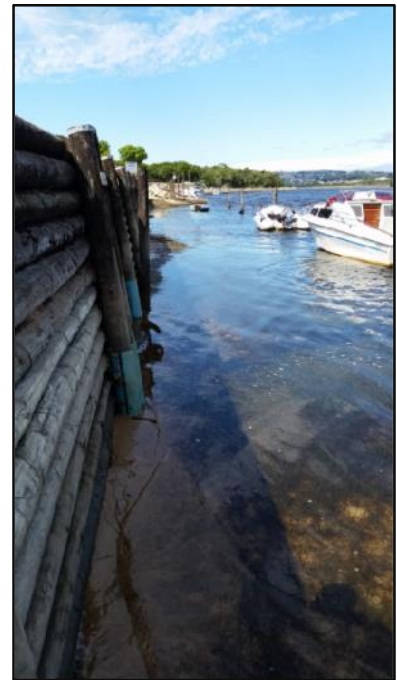
The existing vertical wooden retaining wall does not resemble natural river bank gradients or allow natural processes to take place. The creosote treated timber also leeches chemicals into the water.

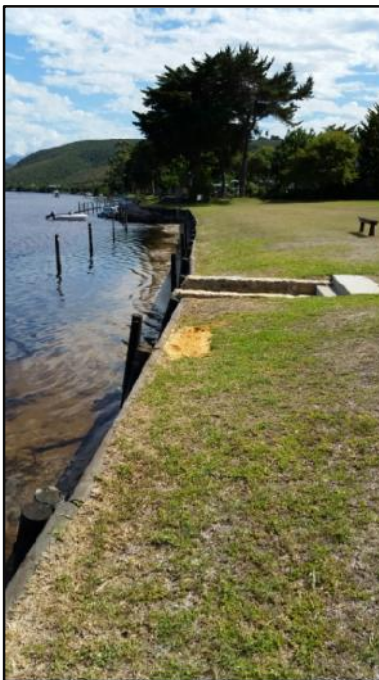
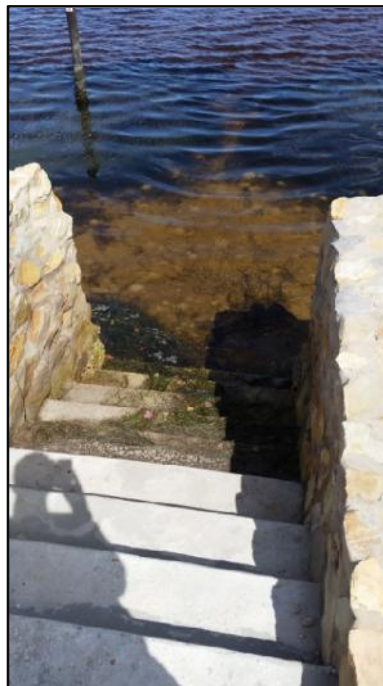
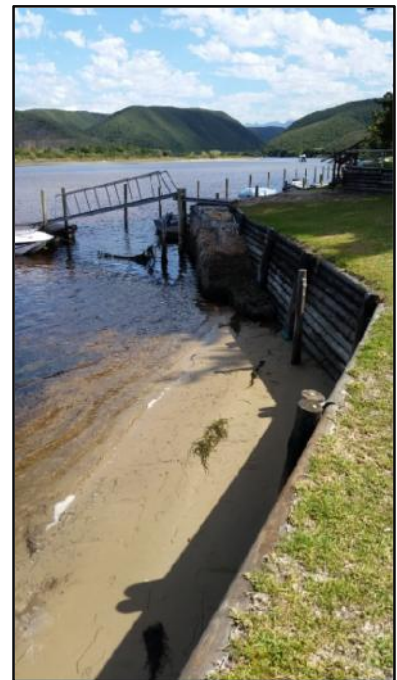
There are existing concrete stairs to access the mooring poles. Floating jetties will be attached to walkways accessible from these stairs.
