SPECIALIST BASIC ASSESSMENT REPORT
FOR THE PROPOSED RIVER BANK MAINTENANCE AT
SILVERSTREAM ESTATE ERF 508, PLETTENBERG BAY

Prepared for Hilland Environmental

Confluent Environmental (Pty) Ltd

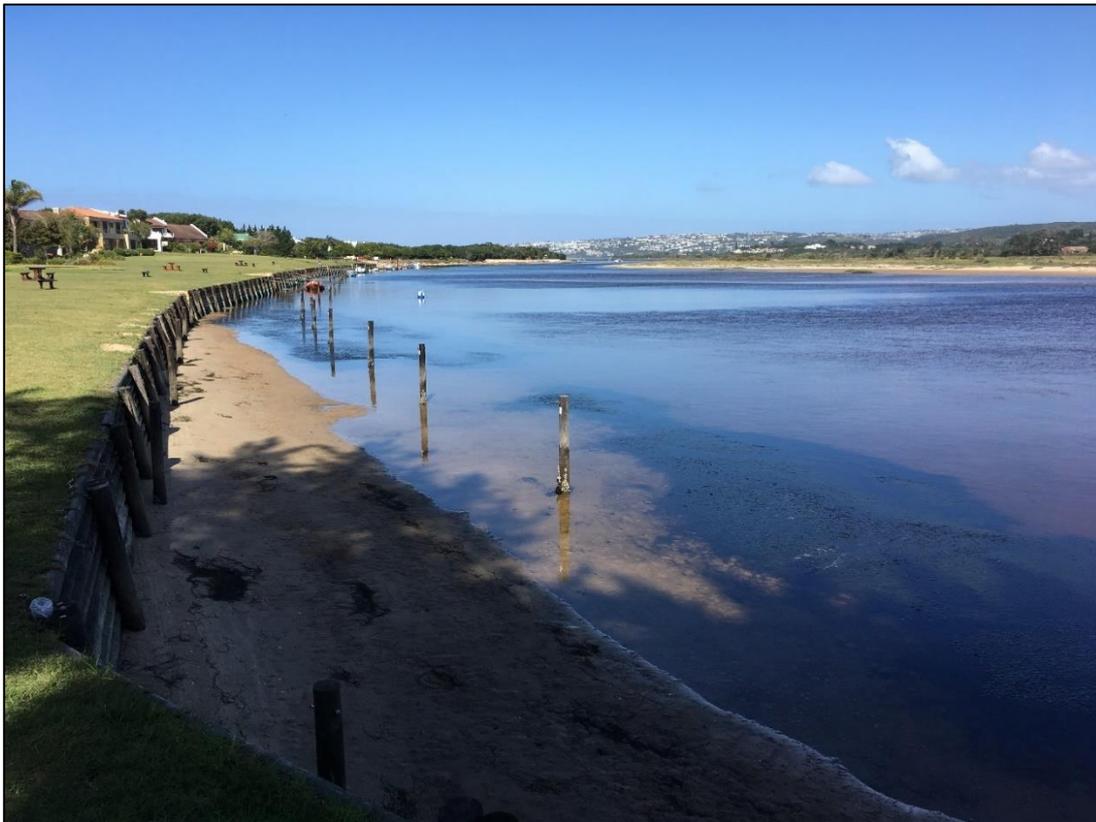
Figure 2: Photograph of the current bank stabilization structure and boat mooring design at Silverstreams Estate. Patches of *Z. capensis* are also visible.

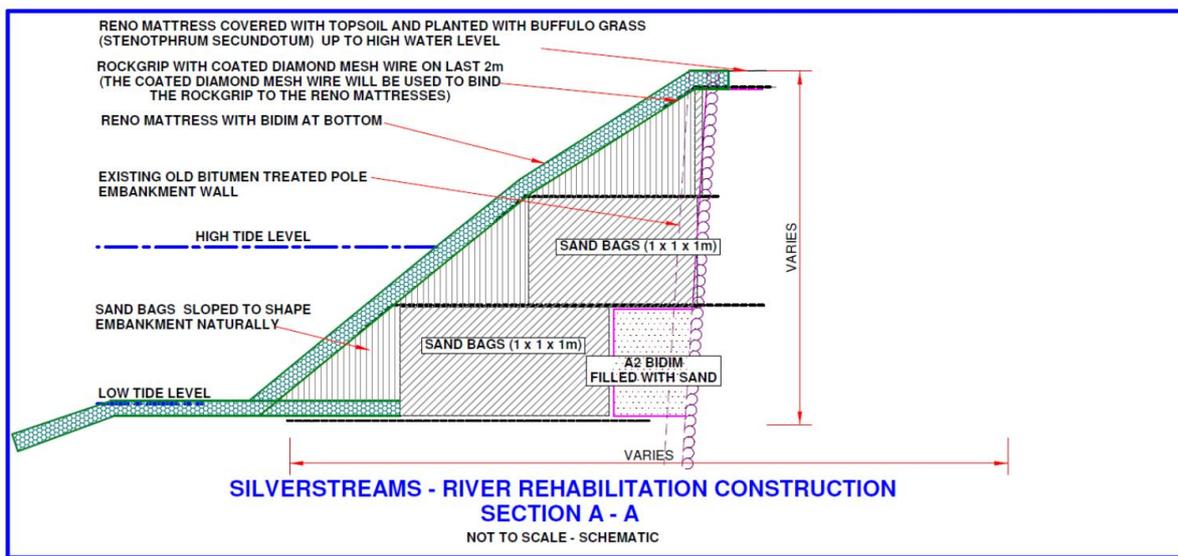
Figure 3: Cross section of the proposed construction of a sloping reno mattress and sand bag

The proposed upgrades entail the replacement of the existing creosote timber poles and vertical river bank retaining wall with a sloping stepped sandbag foundation covered by a reno mattress construction (**Figure 3**). The reno mattress will be re-vegetated with indigenous riparian plants that are suited to the salinity profile of the bank (i.e. salt marsh species near the base and more terrestrial species further up the slope, with a mixture of coastal thicket species, coastal fynbos species and salt tolerant grasses to bind the soil). It is planned that construction of the bank will only take place at the end of the current retaining wall lifespan (i.e. when these poles are rotting and require replacement).

It is proposed that the reno mattress will extend from the top of the existing retaining wall sloping downwards into the estuary, meeting the bed of the estuary approximately 4.5 m beyond the line of the existing retaining wall. The toe of the reno mattress will extend approximately another 2.5 m further into the estuary and will terminate below the line of the floating jetties (**Figure 4**). Timber walkways will link the top of the retained bank to the jetty to allow access to the boats without having to walk up and down the reno-mattress bank which will be re-vegetated.

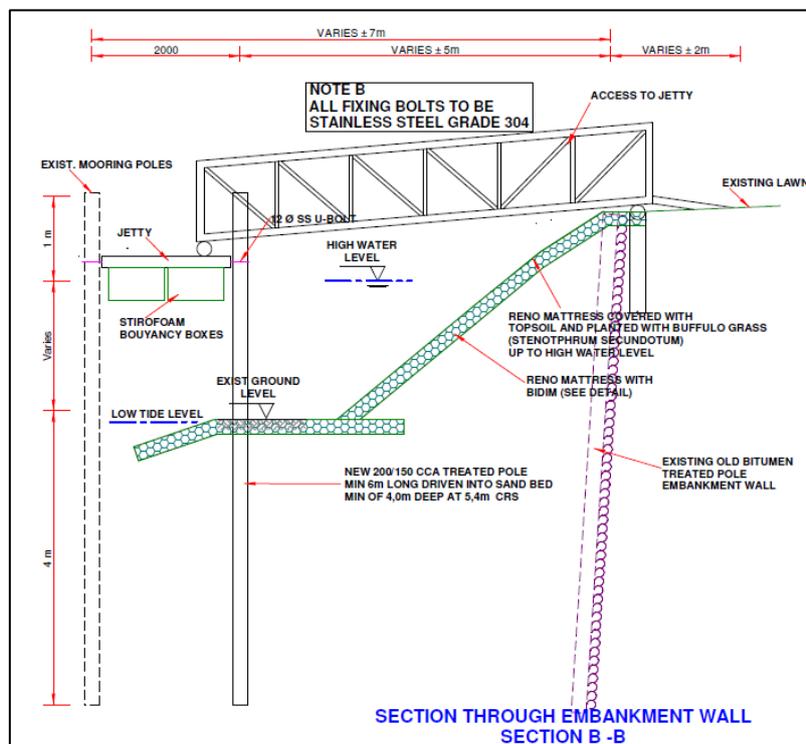
Figure 4: Cross section of the proposed design reno mattress embankment and associated floating jetty infrastructure.

worms. Alternatively, non-covered, suitable polywood poles will be selected. Six floating jetties are proposed to be attached to the new mooring poles. Each jetty will measure approximately 9700 mm X 1500 mm and will be attached to a narrow ramp accessible from existing steps (Figure 5). These jetties will be extended by an additional 9700 mm in the future. The design will result in large gaps (approximately 40 m) between each jetty structure.

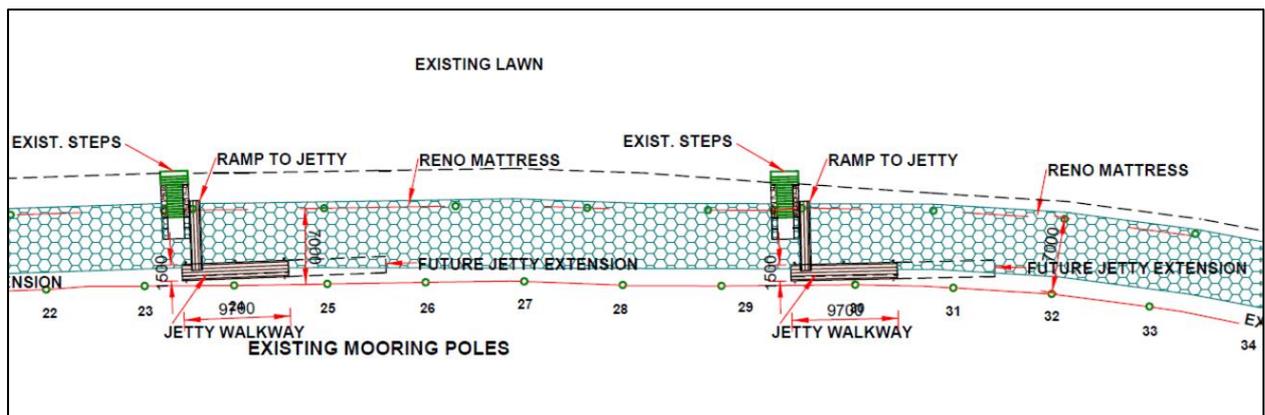
Figure 5: Plan view of the layout of a section of the floating jetties

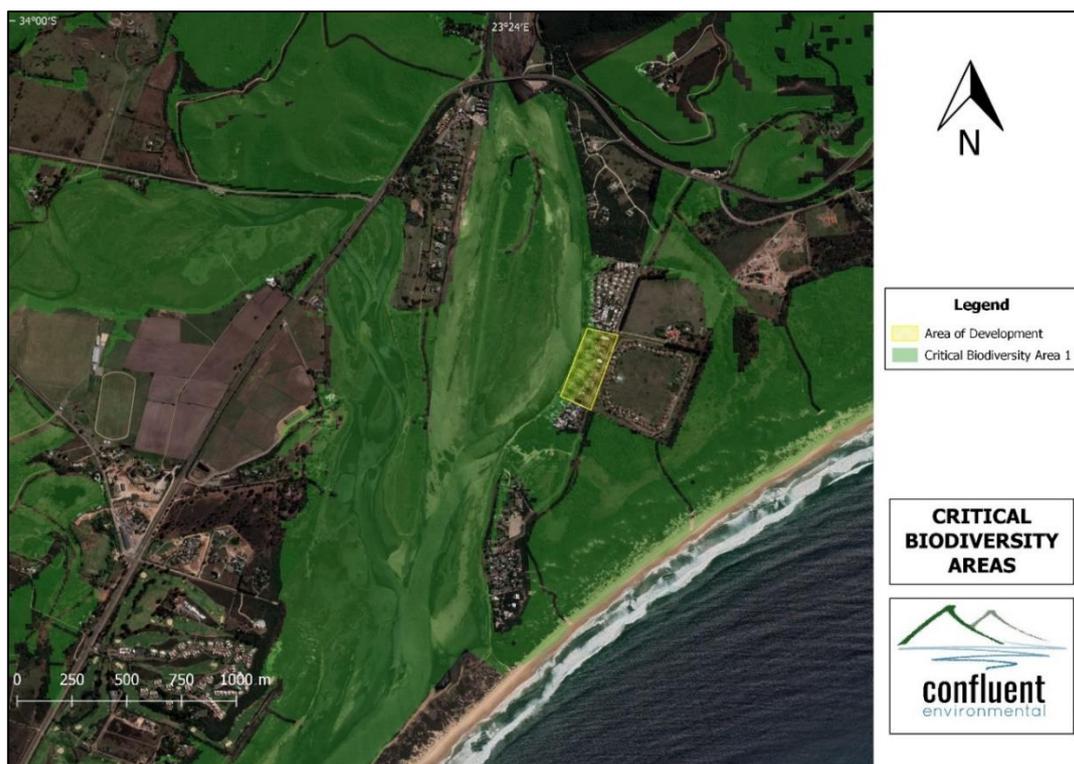
Figure 6: Map indicating the area of development in relation to Critical Biodiversity Area 1 as indicated by the Western Cape Spatial Biodiversity Plan.

- The Keurbooms estuary falls within a Critical Biodiversity Area 1 (CBA1) (**Figure 6**).
 - CBA1 areas are regarded as areas in a natural condition that are required to meet biodiversity targets, for species, ecosystems or ecological processes and infrastructure

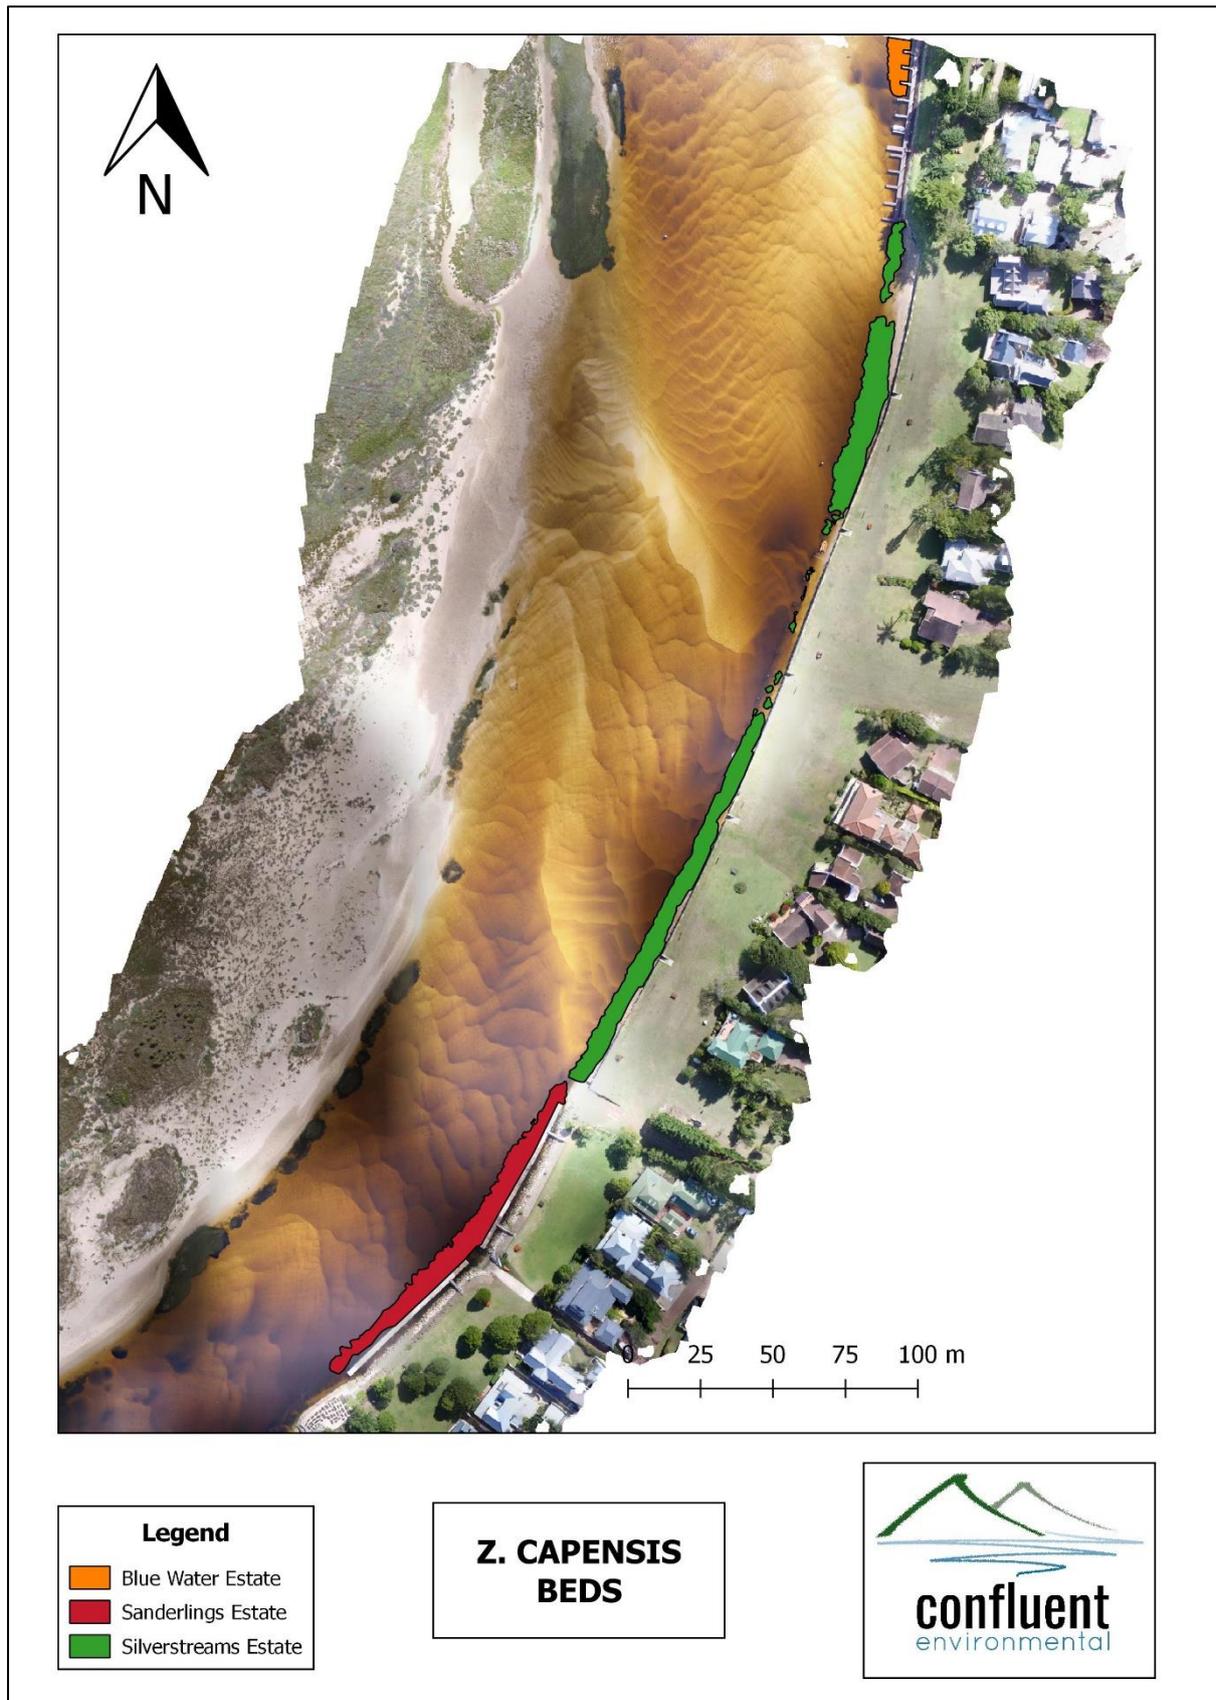
Figure 7: Extent of *Z. capensis* beds adjacent to three estates bordering the Keurbooms Estuary

The orthophoto generated from the drone survey was used to map and quantify the extent of aquatic macrophytes growing adjacent to the banks of the Silverstreams, Blue Water and Sanderlings estates (**Figure 7**). The snorkelling survey confirmed that all vegetation mapped in **Figure 7** was *Z. capensis*. In total, approximately 1900 m² of *Z. capensis* grows adjacent to the bank of the Silverstreams Estate. Visual inspection of jetty developments at the Blue Water and Sanderlings estates showed that *Z. capensis* was not growing beneath the jetties, most likely due to the lack of light penetration into the water column and the alteration of substrate from sand to reno mattress. There are however extensive beds of *Z. capensis* situated directly adjacent to the jetties (**Figure 8**). Fish and estuarine invertebrates were abundant in amongst the eelgrass beds as well as in association with the jetty structures which provide good cover and habitat. The entire length of the Silverstream Estate falls within a no-wake zone, where boats may not exceed a speed limit of 10 km/h.

This suggests that the existing beds visible in Figure 7 (including those present on the opposite bank where no development has taken place) took between 2 to 5 years to establish to their current extent.

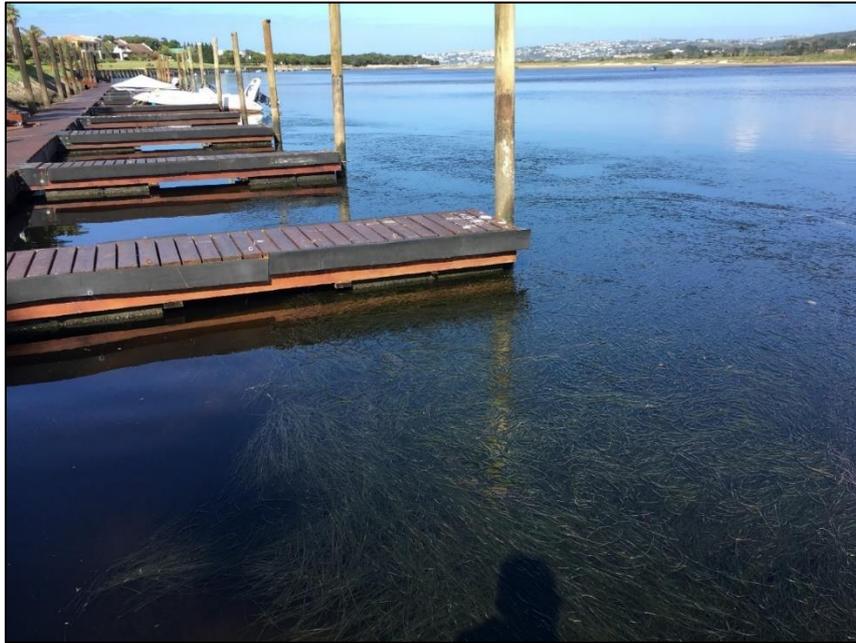
Figure 8: *Zostera capensis* growing in close proximity to an existing floating jetty structure at the Blue Water Estate

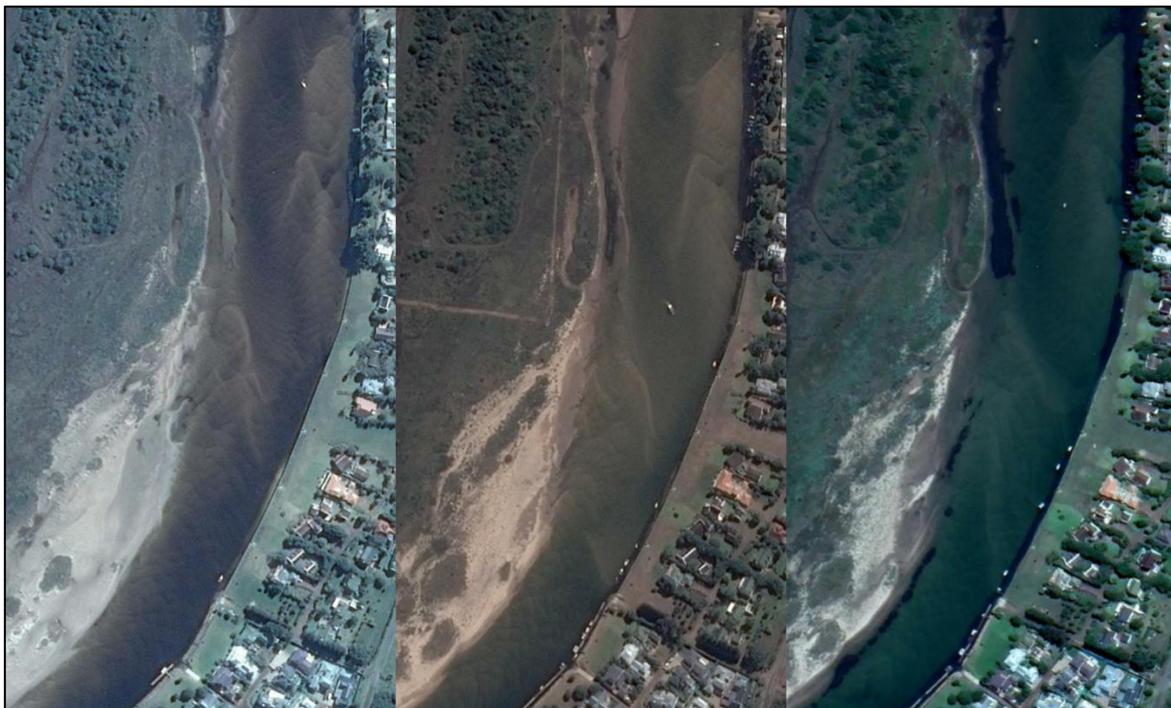
Figure 9: Historical imagery illustrating the development of *Zostera capensis* beds in 2013 (left), 2016 (middle) and 2018 (right).

Figure 9 illustrates how beds of *Z. capensis* have established since 2013, when no evidence of the presence of the species is apparent. Evidence of beds starting to establish is apparent in 2016, while expansive beds are currently present (2018).

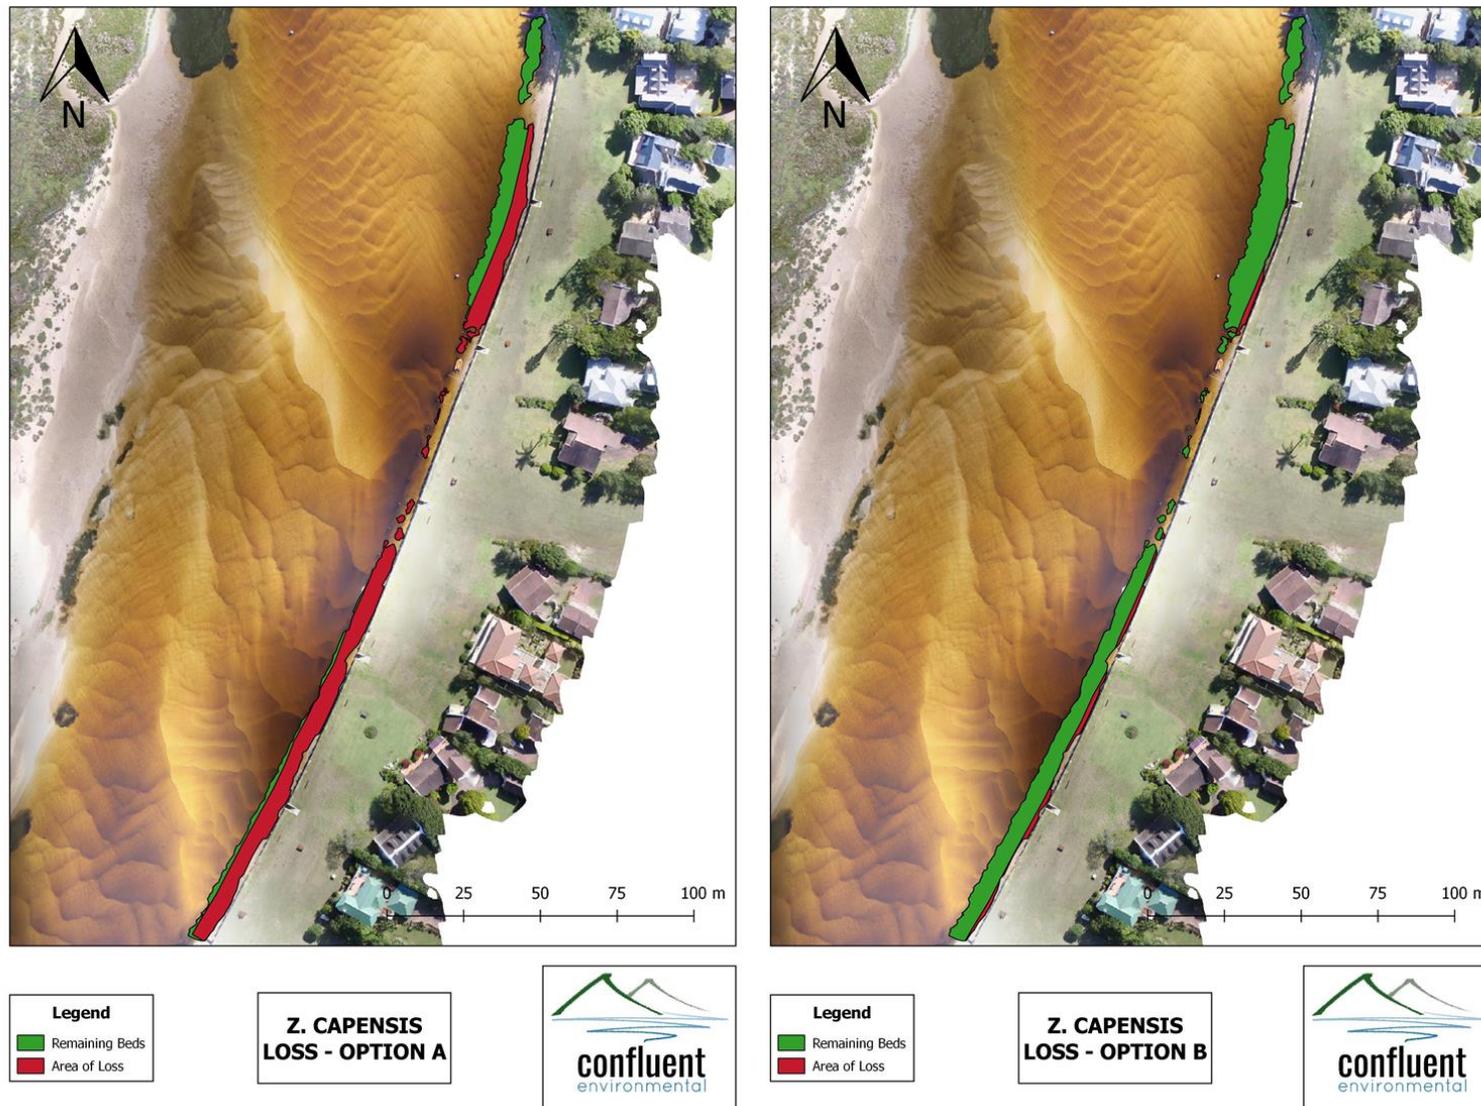
Figure 10: Estimated loss of *Z. capensis* beds under upgrade options A and B.

Under option A, the placement of sand bags and reno mattress (with the toe extending below the line of the floating jetties) will cover large portions of existing *Z. capensis* beds that occur along the bank of the Silverstreams Estate. Given the vulnerable IUCN status of *Z. capensis* and its value to estuarine ecosystems (including the provision of habitat for the endangered Kynsna seahorse) the construction of the bank represents a potentially significant impact. Under option A, the physical footprint of the reno mattress would result in the loss of approximately 1286 m² (67 %) of the existing *Z. capensis* beds (Figure 10). In contrast, option B would result in only 174 m² (9 %) loss of *Z. capensis* beds and therefore represents a significantly lower level of impact.
