APPENDIX C: PHOTOGRAPHS

INPUT FROM AQUATIC SPECIALIST, CONFLUENT ENVIRONMENTAL, APPENDIX G:

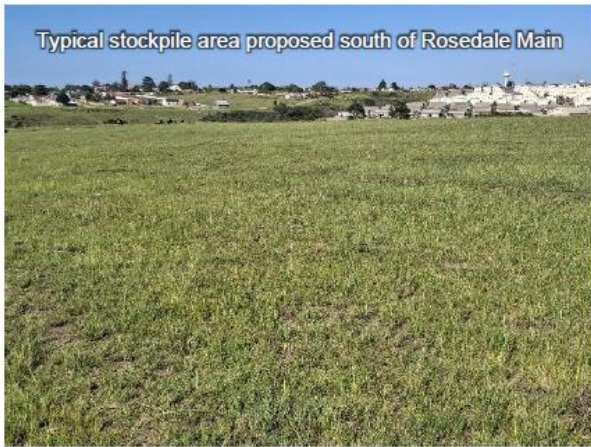
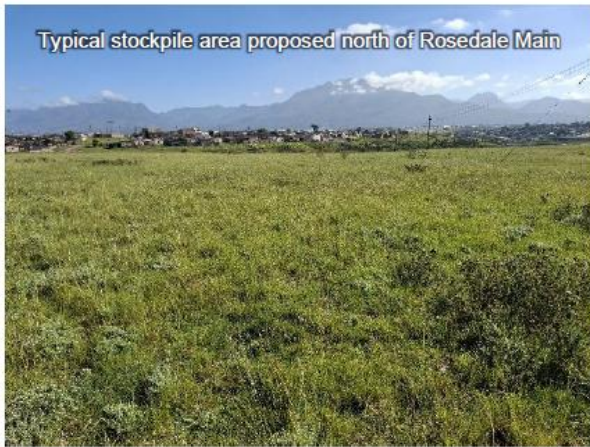
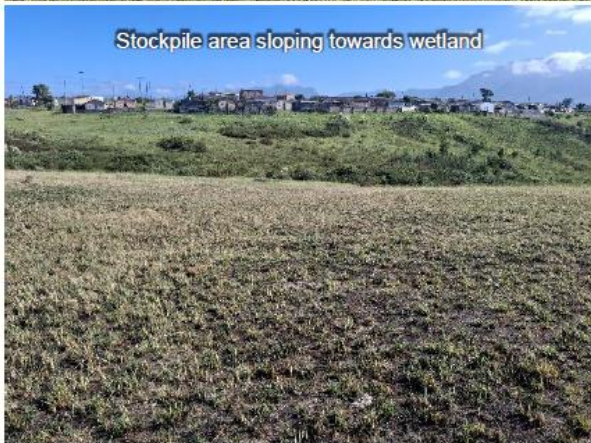
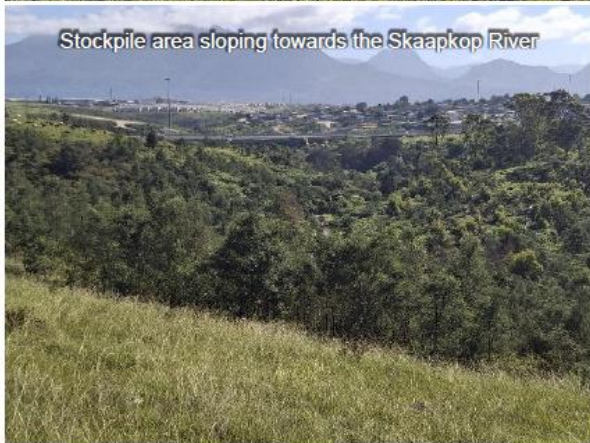
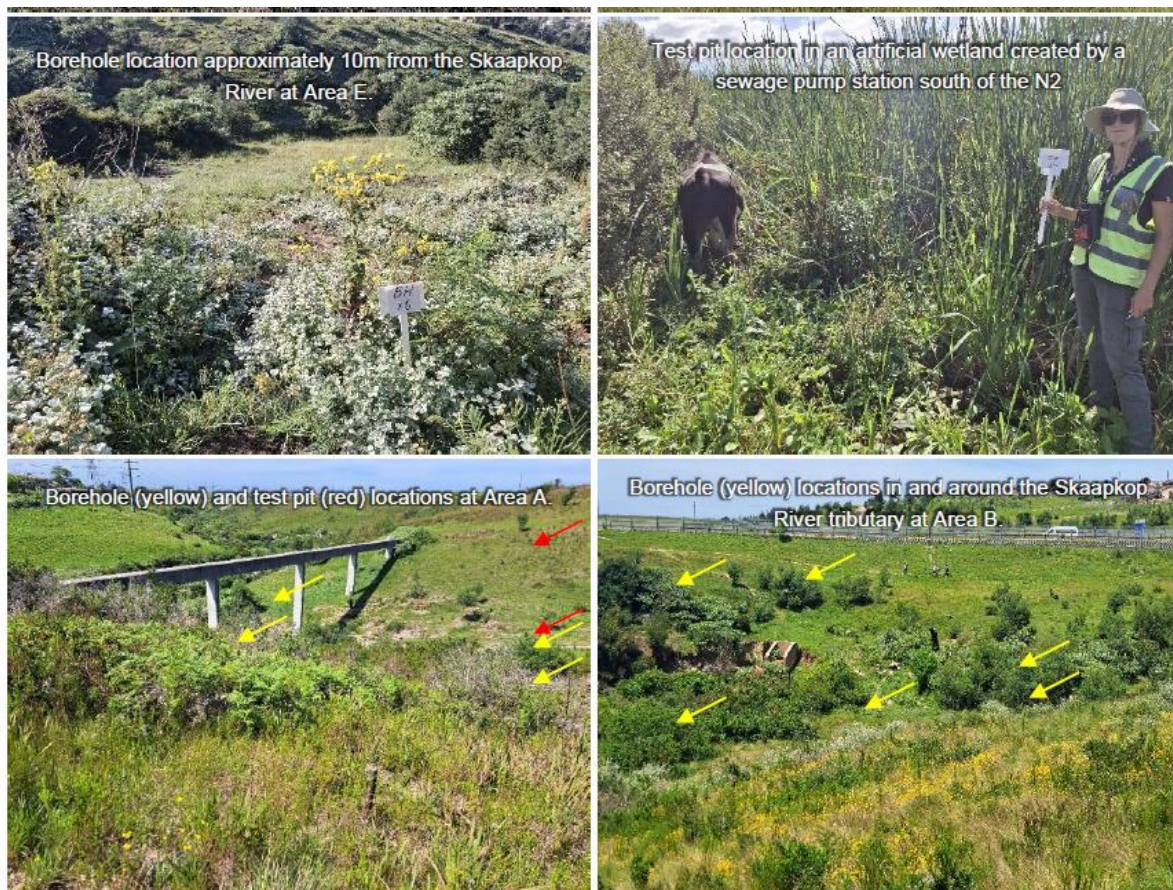
Figure 14. Photos of stockpile, borehole and test pit areas.

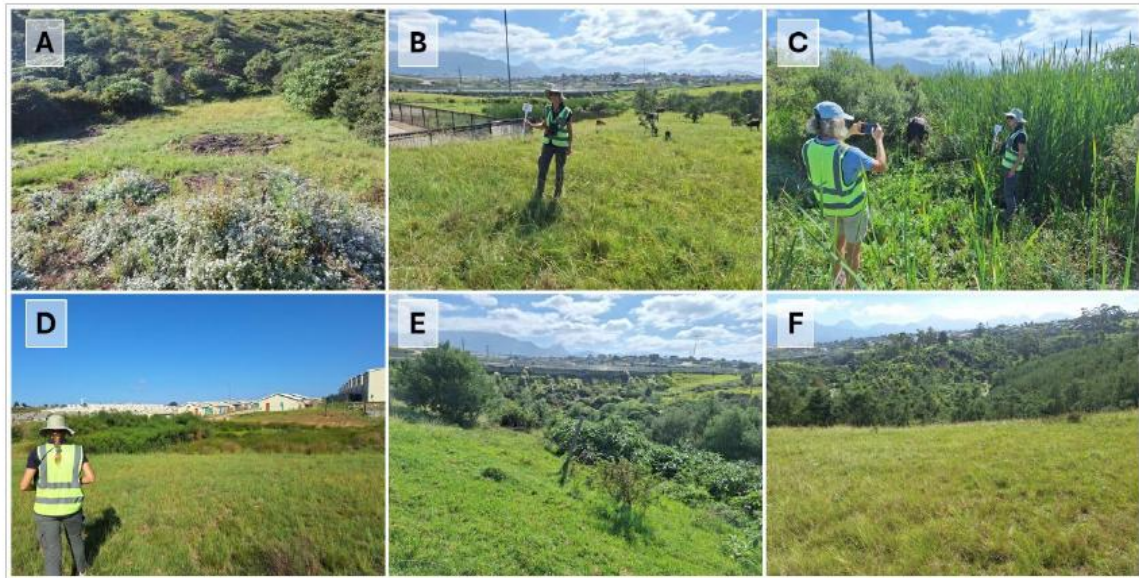
*Figure 9. Habitat types identified within the stockpile, test pit, and borehole sites with A) showing the area in which a test pit is proposed with bushy vegetation in the foreground where golden mole evidence was found; B) a test pit site located in the transformed field habitat; C) a test pit site located in an artificial wetland area; D) a wetland area situated outside of the proposed stockpile area shown in the foreground; E) dense invasive alien plant species in the watercourse just south of the N2 shown in the background and; F) part of the stockpile area (foreground) sloping towards the invaded watercourse (background), which is referred to in the Aquatic Specialist's Report.*

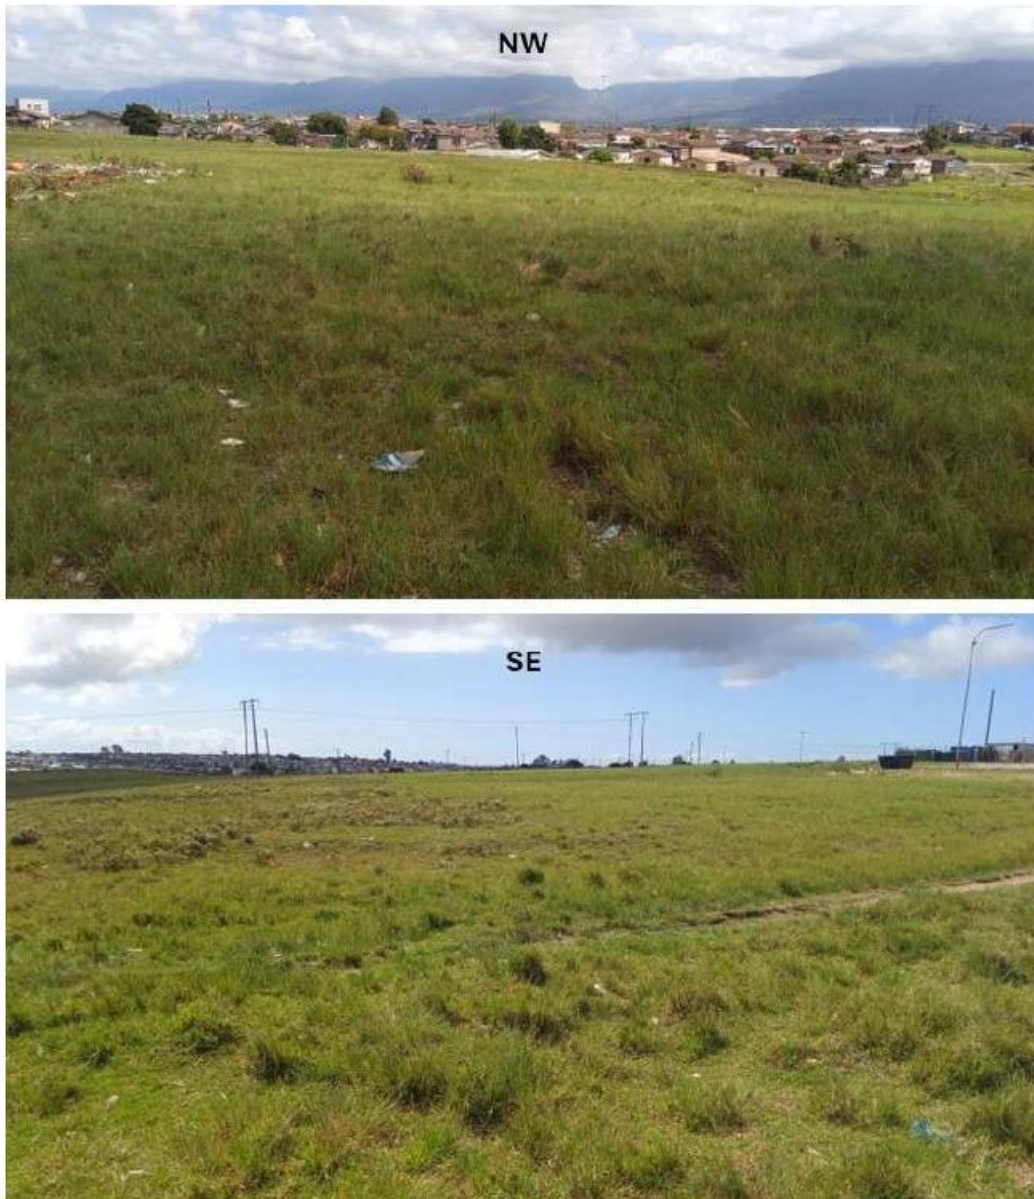
Figure 5. Examples of proposed stockpile sites in the vacant areas between Rosedale (top), Thembaletu and the Outeniqua Waste Water Treatment Works (bottom).

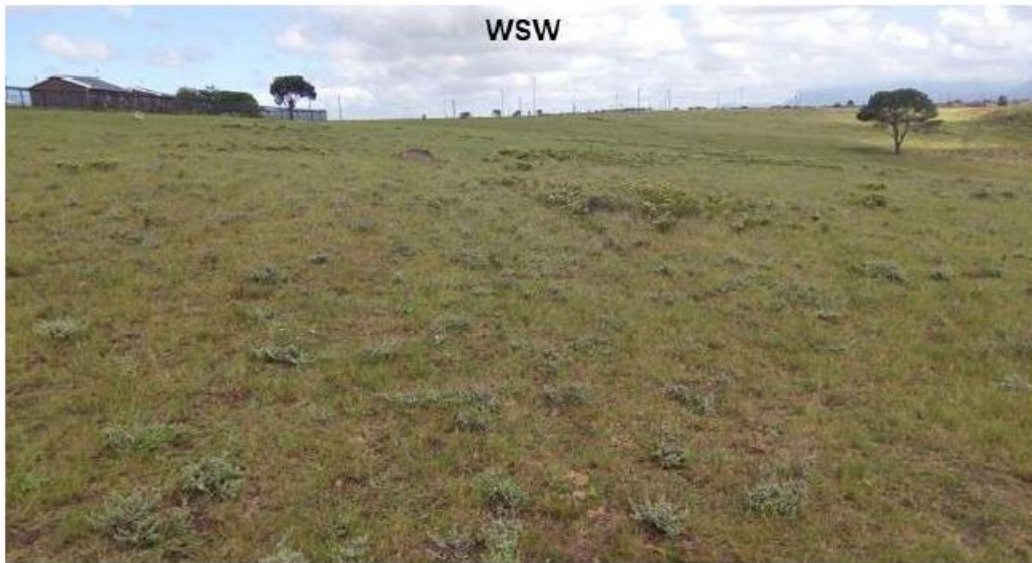
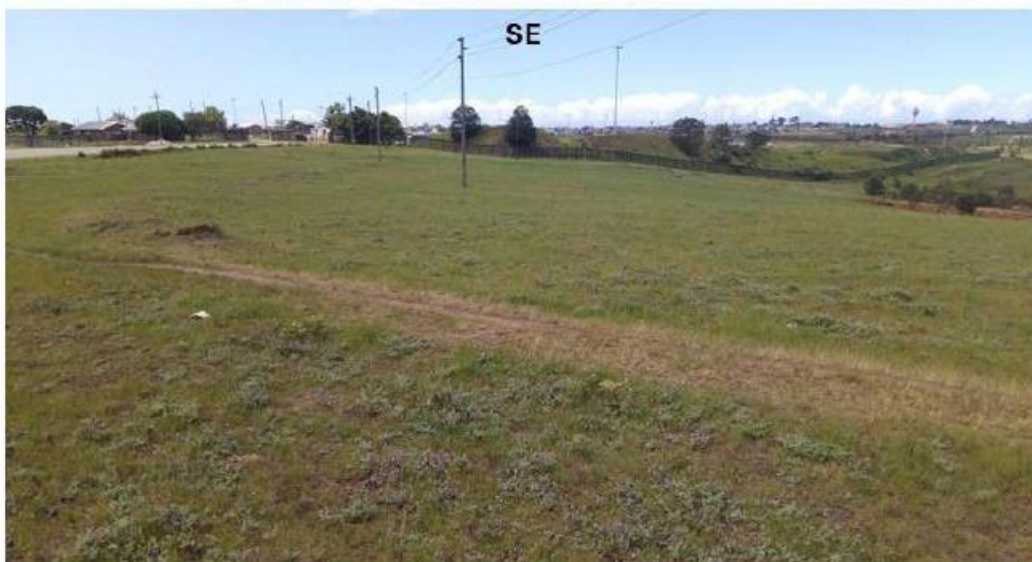
Figure 6. Examples of proposed stockpile sites in the vacant areas between Rosedale, Thembaletu and the Outeniqua Waste Water Treatment Works (visible in both images).

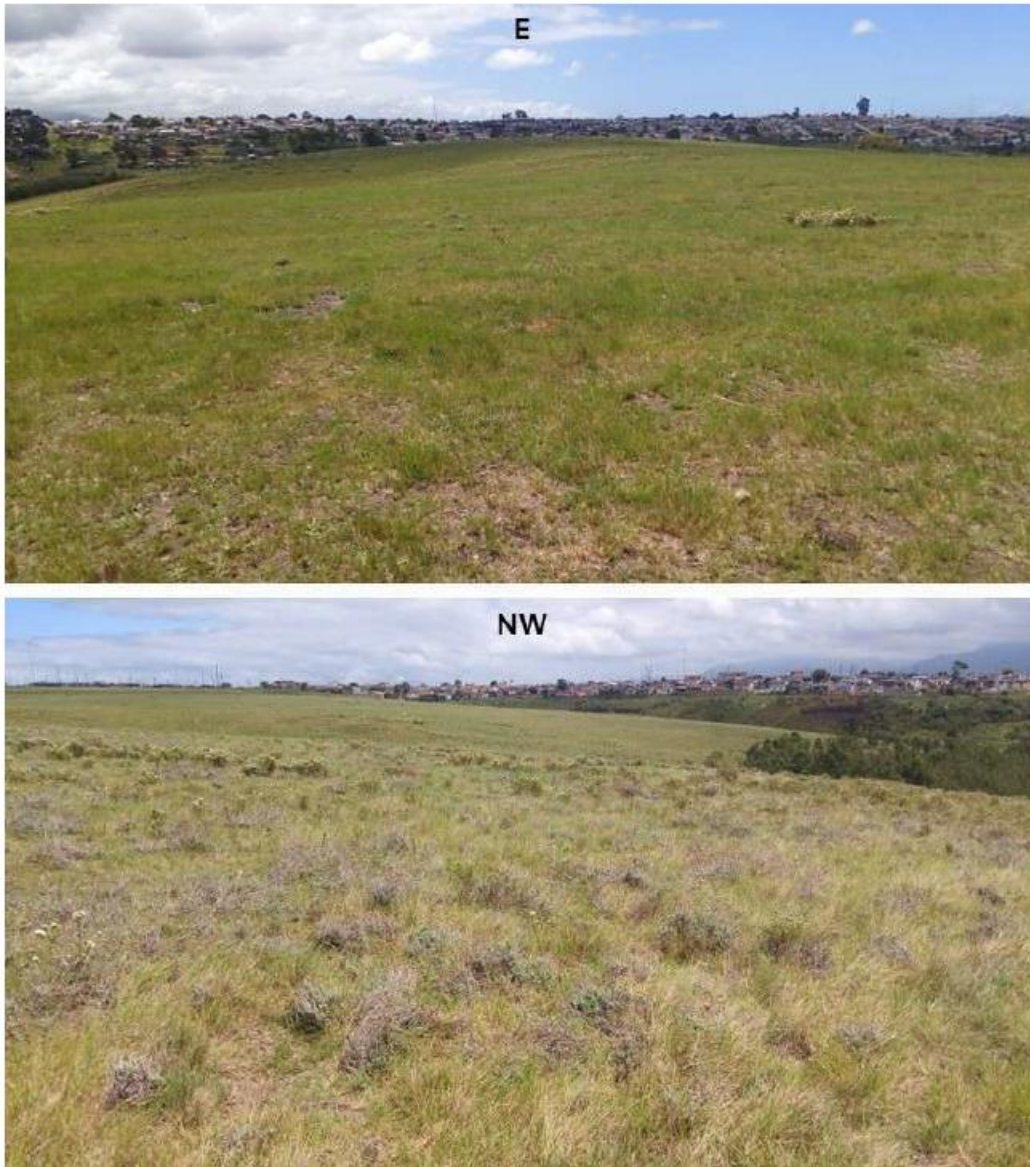
Figure 7. Examples of proposed stockpile sites in the vacant areas between Rosedale (bottom), Thembalethu (top) and the Outeniqua Waste Water Treatment Works (OWWTW).

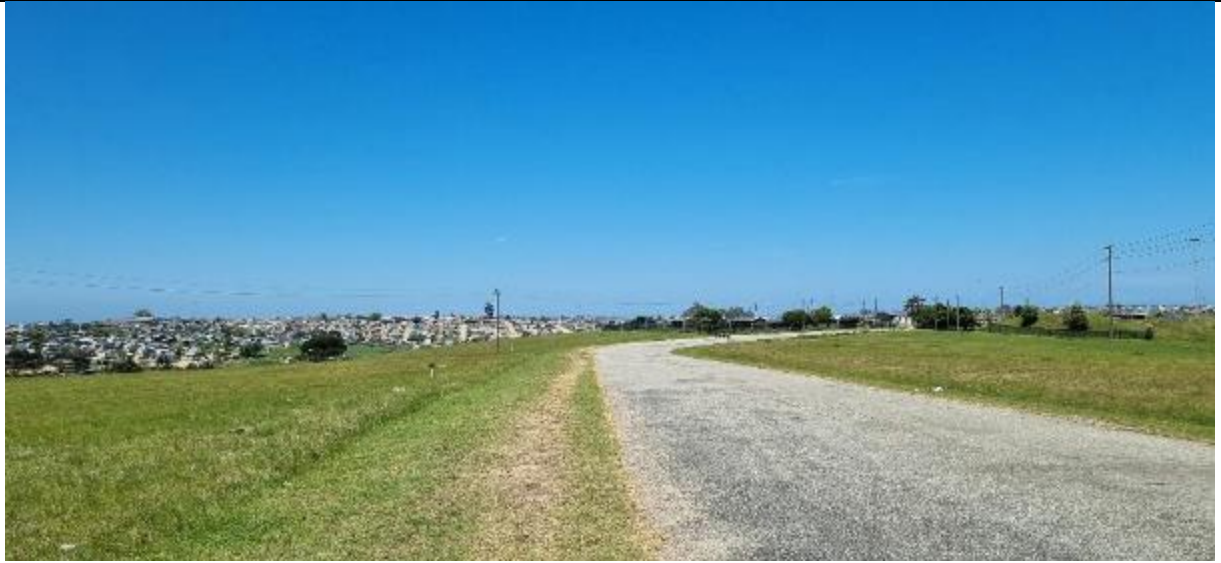
| _ID | 24 |

| _REMARKS | Stockpile/ Camp 1 view south |
| Risk | Medium to High |
| Motivation | Very high visual exposure to community |

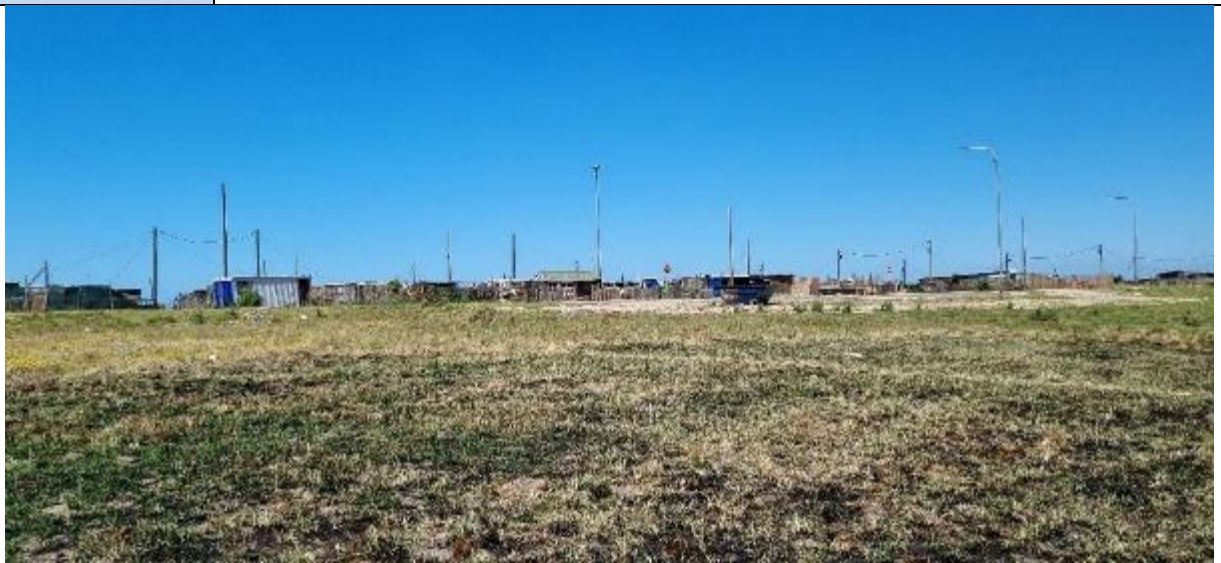
| <b>_ID</b> | 25 |

| <b>_REMARKS</b> | Stockpile/ Camp 1 view west |
| <b>Risk</b> | Medium to High |
| <b>Motivation</b> | Very high visual exposure to community where dust and noise is highly likely to be an impact. |

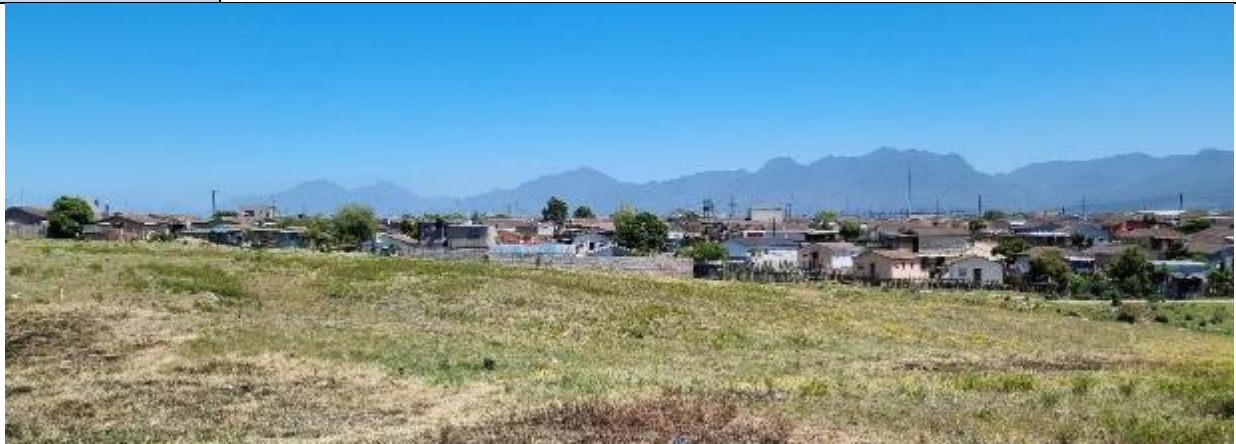
| <b>_ID</b> | 26 |

| <b>REMARKS</b> | Stockpile/ Camp 5 view west |
| <b>Risk</b> | Medium to Low |
| <b>Motivation</b> | Rosedale residential areas with clear visibility but some buffer from the landscape change. |

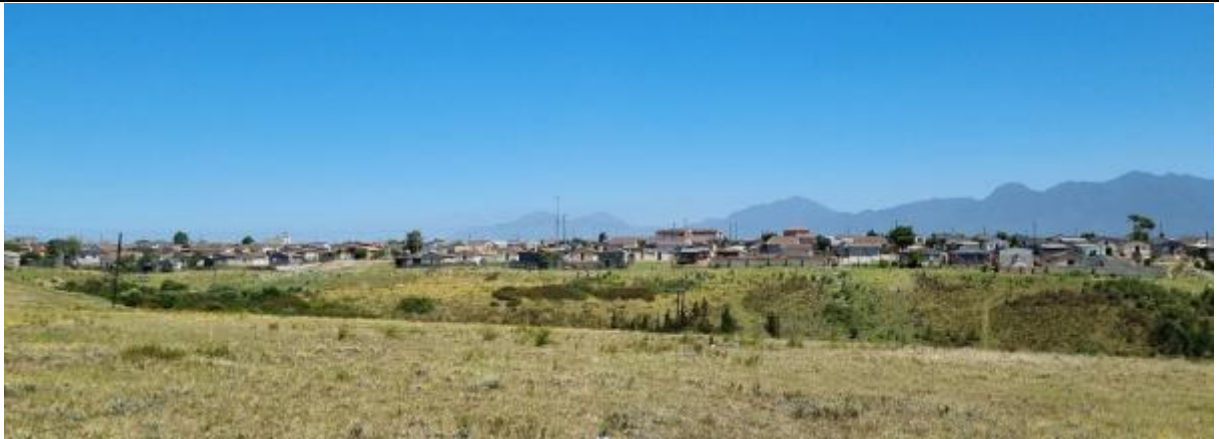
| _ID | 27 |

| _REMARKS | Stockpile/ Camp 5 view east |
| Risk | Medium to Low |
| Motivation | Although the site is clearly visible to the Thembaletu residents, there is buffering from the Skaapkop river. |

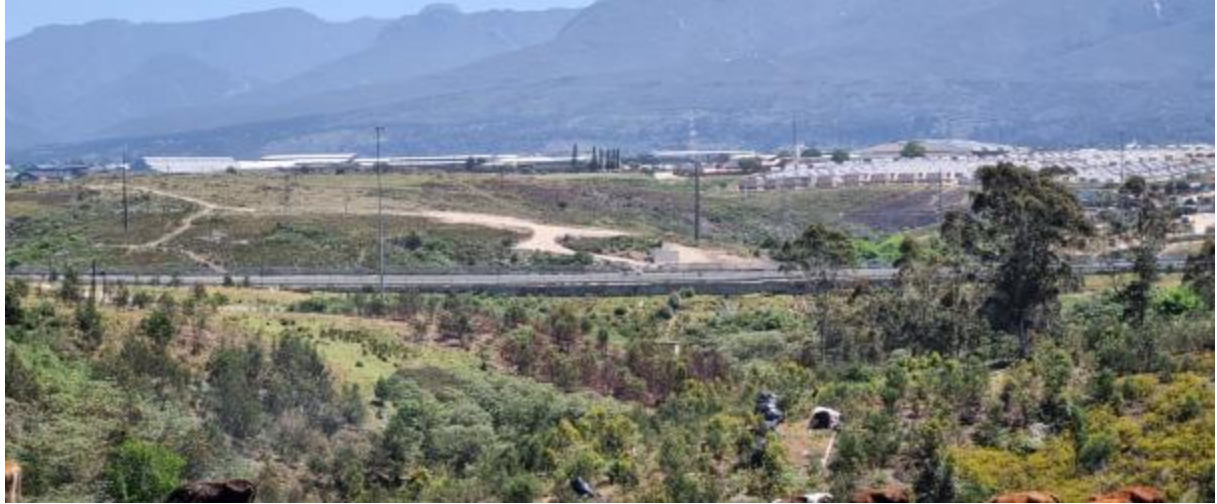
| <b>_ID</b> | 29 |

| <b>_REMARKS</b> | Stockpile/ Camp 4 view east |
| <b>Risk</b> | Medium to High |
| <b>Motivation</b> | Very high visual exposure to Pacaltsdorp Water Works worker dwellings. Not recommended without strict dust mitigation. Planting mitigation required. Thembaletu residential areas are also visible in the background with medium visual exposure (Medium to Low risk). |

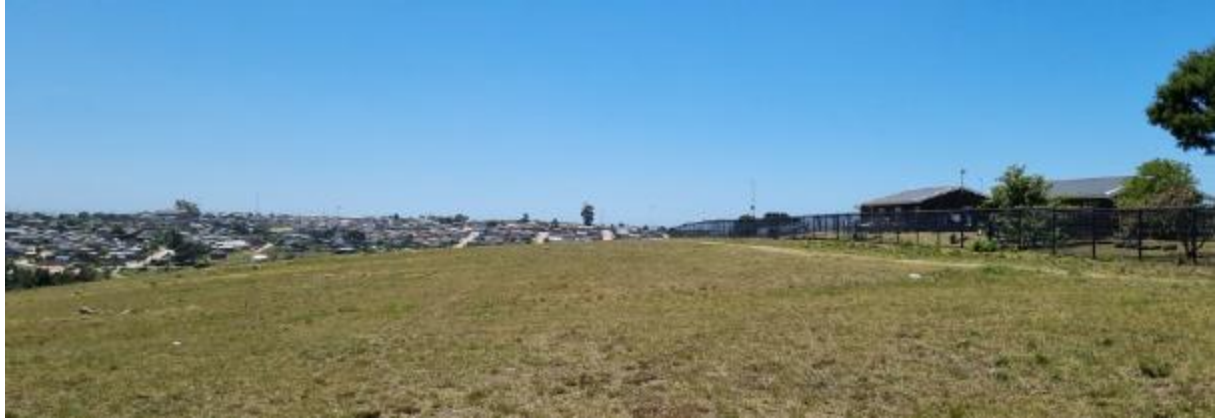
| <b>_ID</b> | 30 |

| <b>_REMARKS</b> | Stockpile/ Camp 4 view northeast |
| <b>Risk</b> | Medium to Low |
| <b>Motivation</b> | High visual exposure to Thembaletu residential located 300m approx. to the northeast of the site. Some buffer from Skaapkop River. |

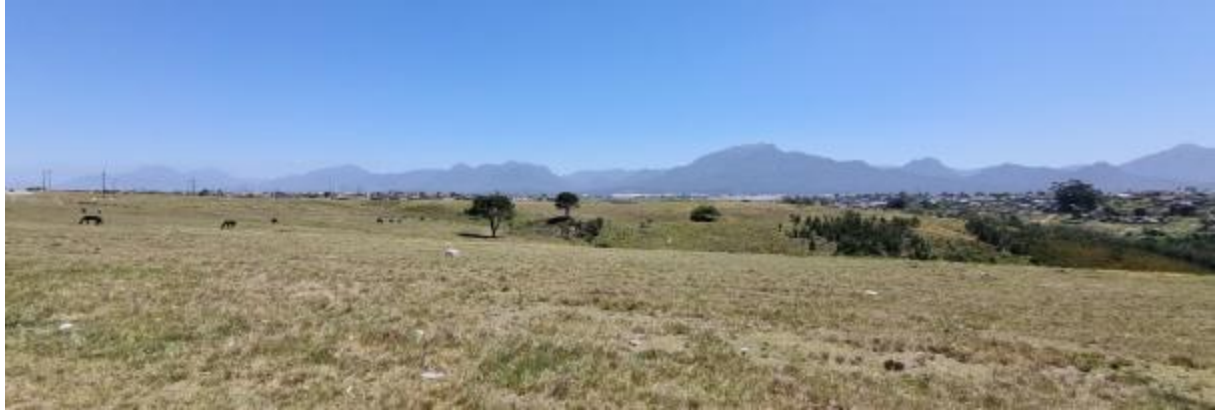
| <b>_ID</b> | 33 |

| <b>_REMARKS</b> | Stockpile/ Camp 3 view south |
| <b>Risk</b> | Medium to Low |
| <b>Motivation</b> | Partial visual screening from proximate receptors with moderate visual exposure to Pacaltsdorp/ Rosedale residential areas. Suitable with mitigation and management of run-off into the small dam in the drainage line. |

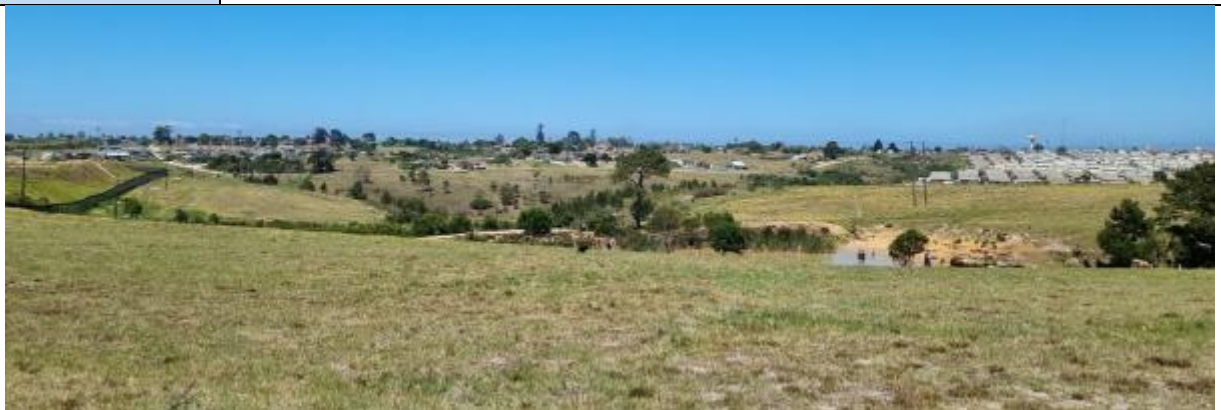
| <b>_ID</b> | 34 |

| <b>_REMARKS</b> | Stockpile/ Camp 3 view north |

| <b>Risk</b> | Medium to Low |
| <b>Motivation</b> | Reduced visibility from topography screening to the north of the site, but with open views to the south and west. |

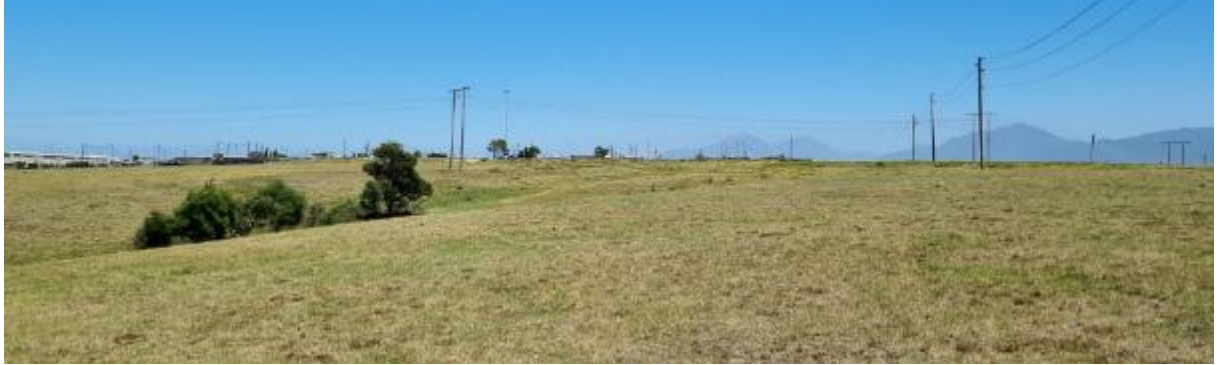
| <b>_REMARKS</b> | Stockpile/ Camp 2 view west |
| <b>Risk</b> | Medium to High |
| <b>Motivation</b> | Very close visual exposure to the adjacent Rosedale informal settlement, and new residential areas. However, the site is buffered from the residential area by the proposed Rand Street Road Development. As such, dust and noise are likely to result in high level impacts to the local sense of place but would be visually associated with the road construction and general development. Mitigation of dust would need to be strictly mitigated. |

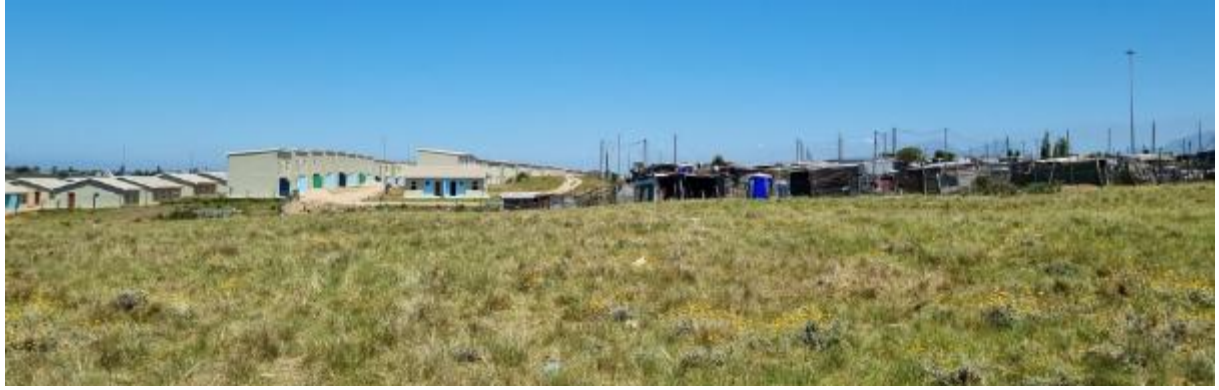
| _ID | 36 |

| _REMARKS | Stockpile/ Camp 2 view west |

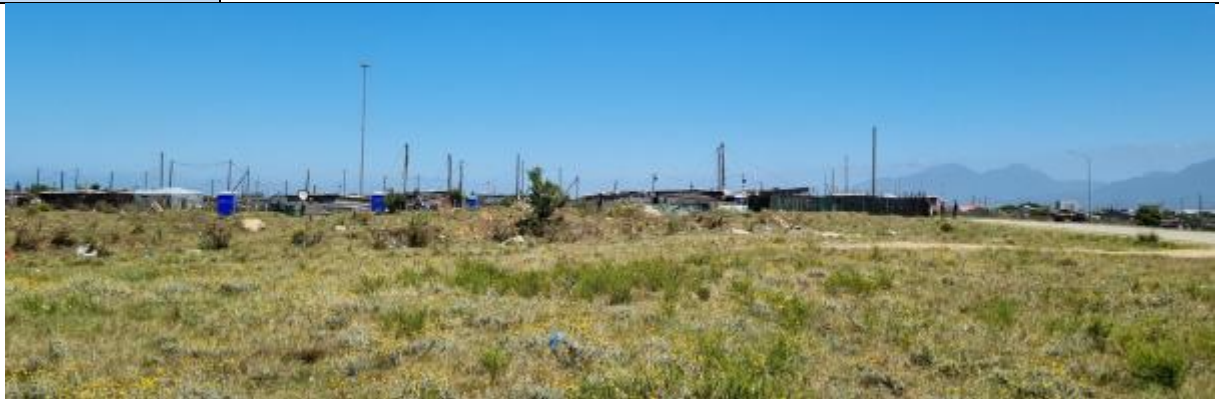
| _ID | 37 |

| _REMARKS | KOP Rosedale Main 1 |

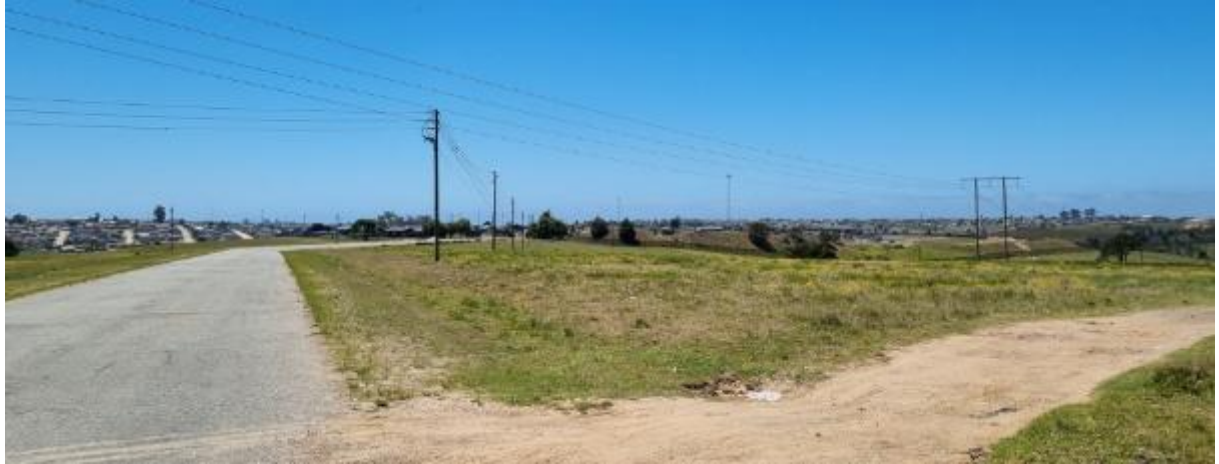
| _ID | 39 |

| _REMARKS | KOP Sarah Crescent Rd |
| Risk | Medium to High |
| Motivation | Very High Visual Exposure to proposed stockpiles/ construction camp 1. Mitigation of dust is required, with Camp 1 not visually preferred (but not a fatal flaw due to short-term duration of impact. |
